Inspection Report

Akamai Structural Inspector LLC

Date: 1/5/2019	Time: 09:00 AM	Report ID: 0105180900TLH
Property:	Customer:	Real Estate Professional:

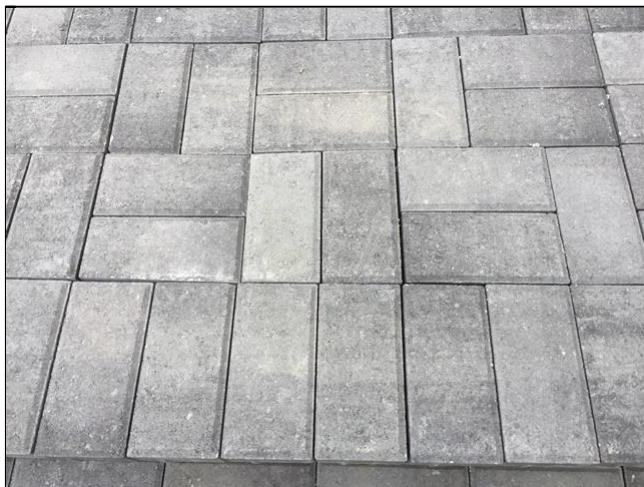
1.1 Item 5(Picture)

(1) Sand missing at paver blocks. This condition was observed at several locations around the structure. The photographs depicted are only representative photographs of this finding. Acceptable building standards state "Prior to final compaction of the surface, all joints should be filled with kiln dried fine jointing sand. All joints should remain full of jointing sand at all times, with periodic checking and re-sanding carried out where necessary." It is recommended that this Finding and all associated components be reviewed and corrected by the Prime Contractor.

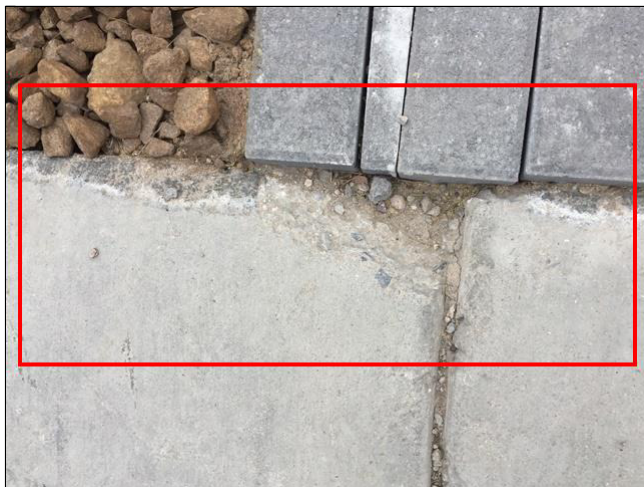
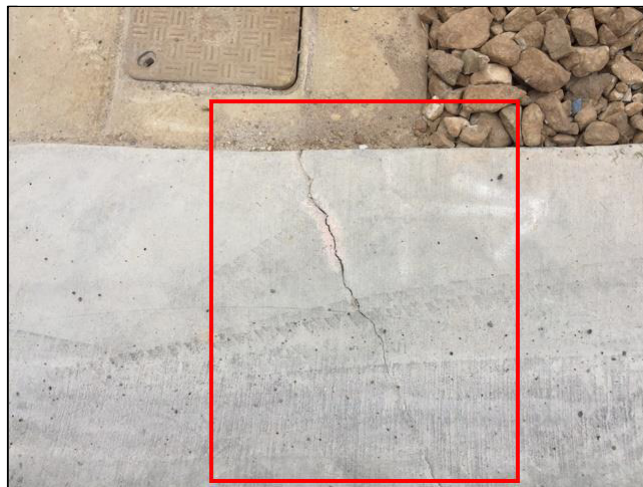
1.1 Item 6(Picture)

(2) Concrete cracks/damage observed. This condition was observed at the front of the property. The photographs depicted are only representative photographs of this finding. Left uncorrected this condition can result in accelerated deterioration. This Finding does not conform the minimum required workmanship or craftsmanship performance standards as defined by the SNHBA and affirmed by the Nevada State Contractors Board. " Concrete should not deteriorate to the extent that the aggregate is exposed or the aesthetics are destroyed under normal use and weather conditions." It is recommended the Prime Contractor review this finding and correct as needed to conform with applicable building standards and practices.

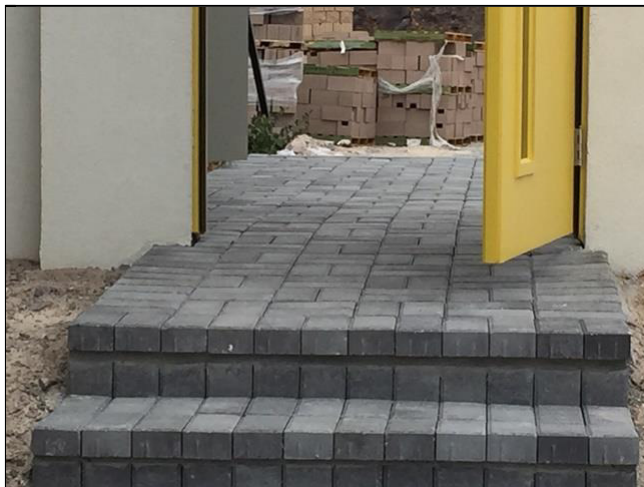
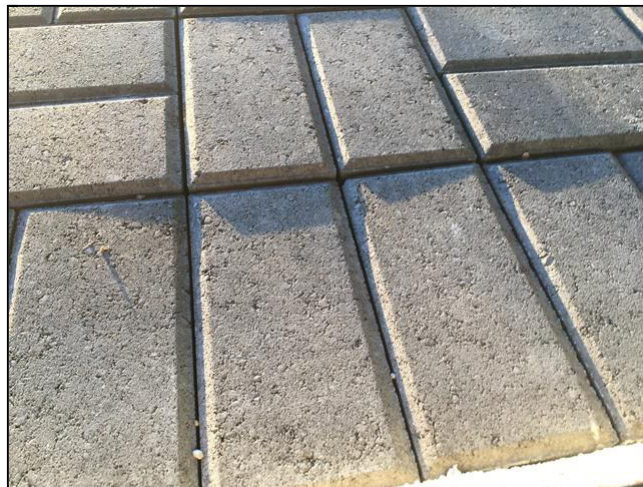
1.1 Item 8(Picture)

(3) Settling of paver blocks. This condition was observed at the front walkway and the rear patio. Refer to the photographs for further clarification. This Finding does not conform the minimum required workmanship or craftsmanship performance standards as defined by the SNHBA and affirmed by the Nevada State Contractors Board. Some settling of the masonry driveway / walkway should be expected. Settling or heaving in excess of a 1/4 inch is unacceptable. It is recommended the Prime Contractor review this finding and correct as needed to conform with applicable building standards and practices.

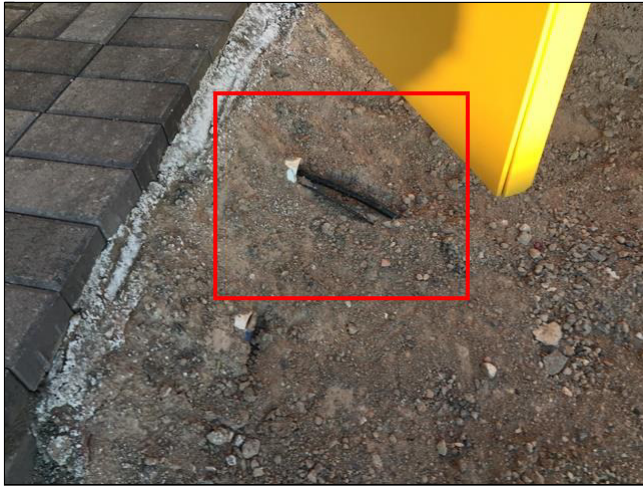
1.5 Item 1(Picture)

Irrigation pipeline unprotected where could be damaged, This condition was located in the court yard. This Finding does not conform the minimum required workmanship or craftsmanship performance standards. It is recommended the Prime Contractor review this finding and correct as needed to conform with applicable building standards and practices.

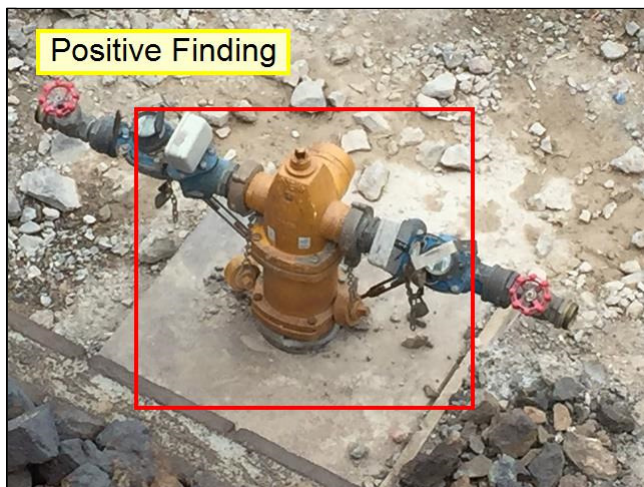
1.10 Item 1(Picture)

(1) Fire Hydrant located in proximity to home. This condition was located at the rear of the property. Refer to photograph for further clarification. Many insurance companies give a discount on the policy rate for a fire hydrant located in close proximity to the property. Check with your insurance provider when you are arranging your insurance on the home. This finding is deemed to be a positive finding.

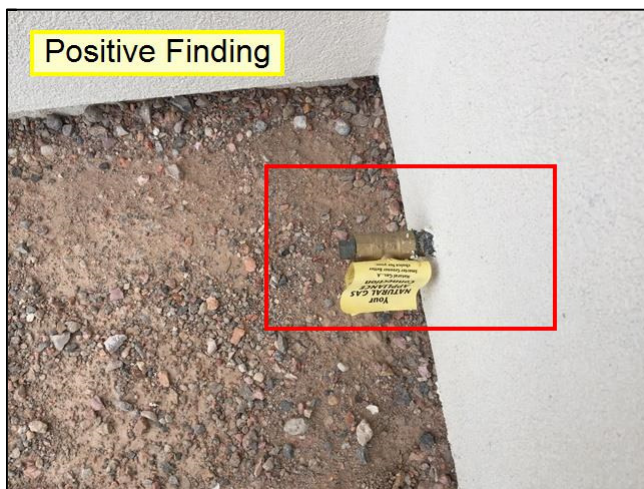
1.10 Item 2(Picture)

(2) Gas outlet observed at rear patio area. This condition was observed at the rear of the structure. Refer to the photograph for further clarification. This outlet is generally an upgrade provided by the builder that will allow the homeowner to install a barbecue grill, a deck heater, or other gas operated appliances on the natural gas main for the home.

The installation of this gas stub is deemed to be a positive feature.

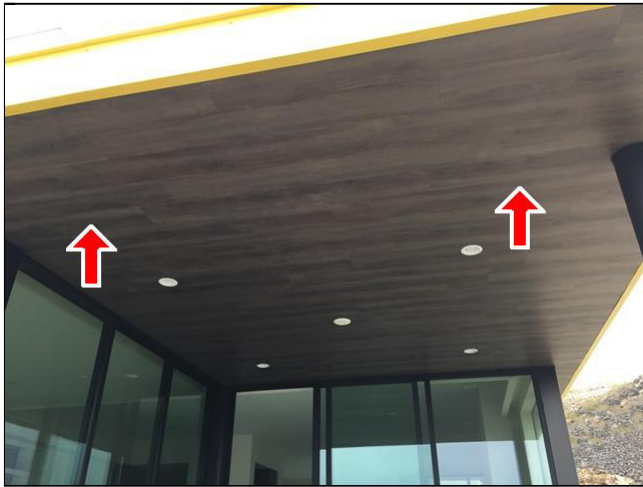
2.1 Item 1(Picture)

Vinyl laminate flooring use in soffit questionable. Refer to photographs for further clarification. Many manufactures take the stance that laminate flooring is not intended for outdoor use. There are some 'weather-resistant' laminates on the market, however most laminate floors are made strictly for indoor use. The flooring would warp and rapidly get damaged under changing weather conditions and would not last very long. Vinyl floor can be used in an outdoor, temperature controlled environment. This means that you can install vinyl flooring in a sun room, enclosed porch, or any other "outdoor" space where you can control the heat and cold. The manufacture of the product should be consulted as to the use in this manner and the installation instructions should be reviewed as to installation.

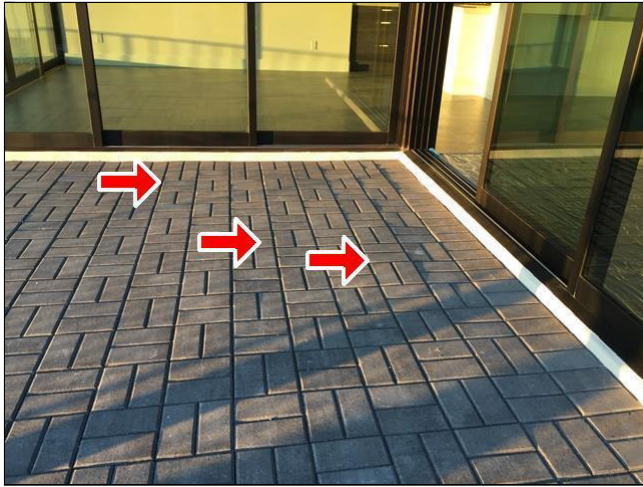
2.4 Item 1(Picture)

Improper drainage at rear patio. The pavers at the sliding glass doors are sloped into the building. The photographs depicted are only representative photographs of this finding. This Finding does not conform the minimum required workmanship or craftsmanship performance standards. It is recommended that this Finding and all associated components be reviewed and corrected by the Prime Contractor.

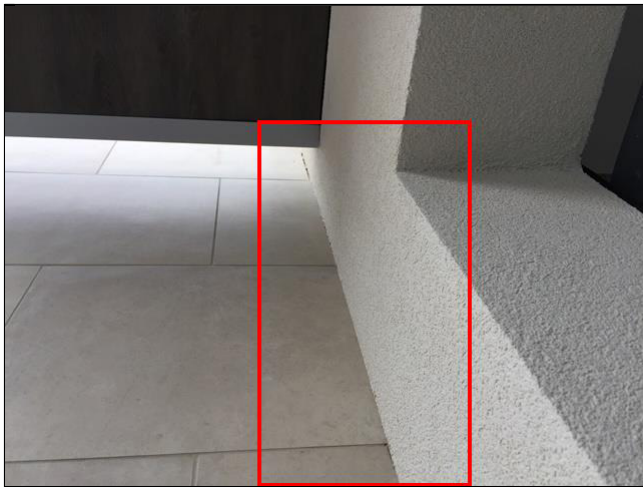
2.5 Item 1(Picture)

General caulking and sealing recommended. Caulk / sealing is needed at several locations around the structure. The photograph depicted is only a representative photograph of this finding. This finding does not conform to building standards and practices in effect at the time of construction or installation. It is recommended that this Finding and all associated components be reviewed and corrected by the Prime Contractor.

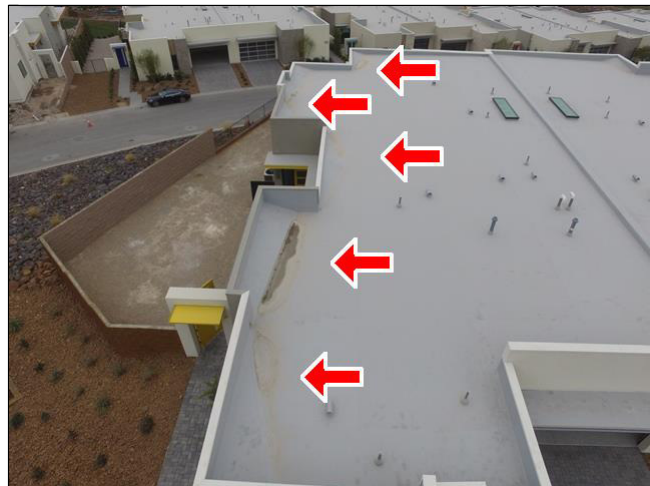
4.0 Item 1(Picture)

Pooling water appears to be observed on roof. Refer to photographs for further clarification. Nevada Contractors board states that " Roof sheathing should have a maximum deflection of 3/8 inch in 2 feet." This Finding does not conform the minimum required workmanship or craftsmanship performance standards as defined by the SNHBA and affirmed by the Nevada State Contractors Board. It is recommended the Prime Contractor review this finding and correct as needed to conform with applicable building standards and practices.

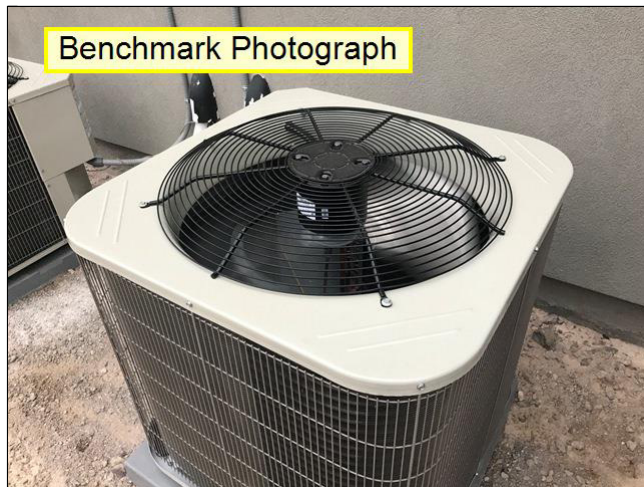
5.0 Item 3(Picture)

(2) Air conditioning testing limited. The client is advised that with exterior temperatures less than 65 degrees placing the air conditioner into normal operation can freeze the compressor and cause serious damage to the entire system. Operation of the systems at temperatures below 65 is advised against by many HVAC manufacturers. Below 65 degrees Fahrenheit the compressor(s) do not operate efficiently and often the temperature readings are inaccurate and representative of actual system operation. Your inspector briefly ran the system as a benchmark to show that the compressor activated and operated.

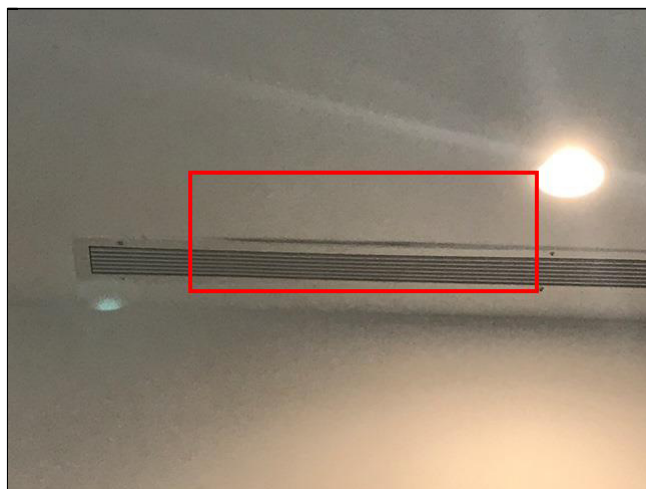
5.2 Item 1(Picture)

Register damaged. This condition was observed at the entry way. Refer to the photograph for further clarification. It is recommended that this Finding and all associated components be reviewed and corrected by the Prime Contractor.

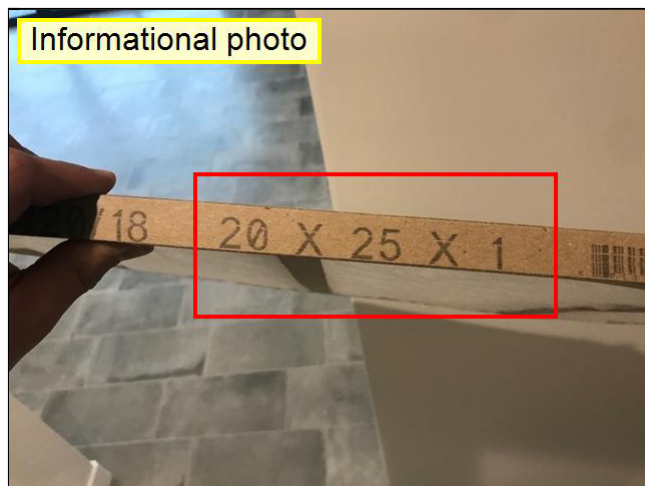
5.4 Item 1(Picture)

Filter size observed. This condition was observed both units in the home. The client is advised that the HVAC system for the home uses disposable filters. These filters should be replaced monthly. The correctly sized filter for the HVAC system is 20 x 20 x 1 and 20 x 25 x 1. 4 filter(s) required for a complete change out.

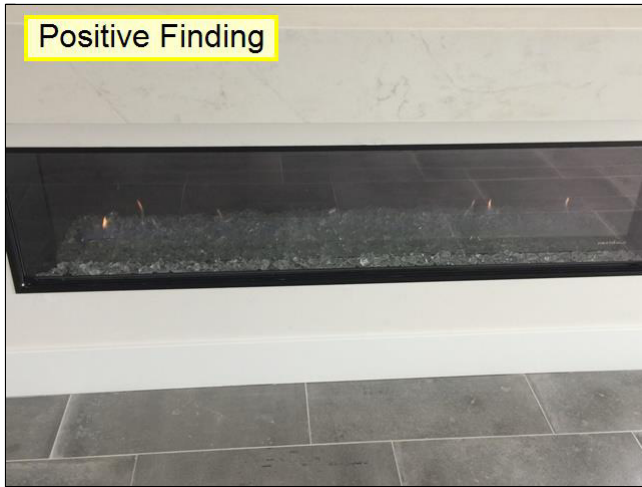
5.6 Item 1(Picture)

Fireplace operation verified. This condition was observed at both fireplaces in the home. The fireplace in the home was operated with no adverse conditions observed. The photograph depicted is only a representative photograph of the finding. This is deemed to be a positive finding.

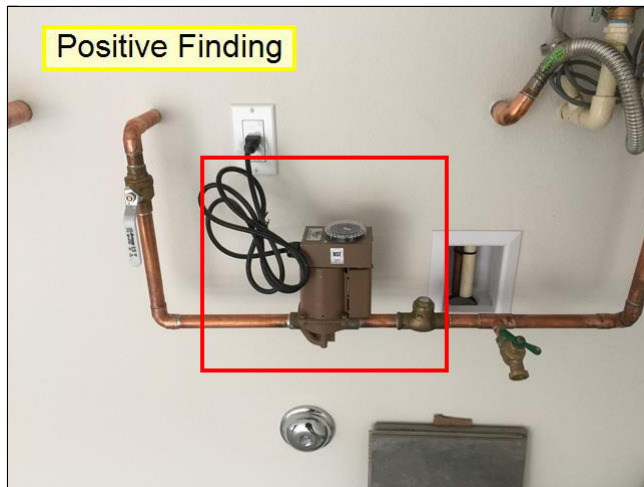
6.0 Item 2(Picture)

(2) A circulating pump was observed in the garage. Refer to photograph for further clarification. This device is intended to provide hot water to features faster and reduce water waste. This is deemed to be a positive finding.

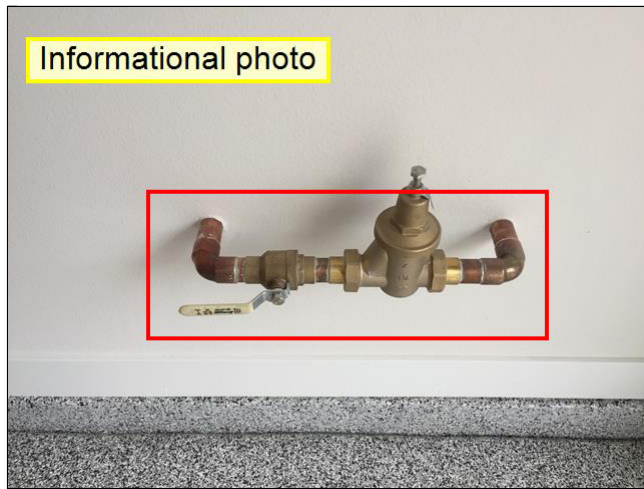
6.3 Item 2(Picture)

(2) The water shutoff was located in the garage. Refer to the photograph for further clarification. This is an informational finding.

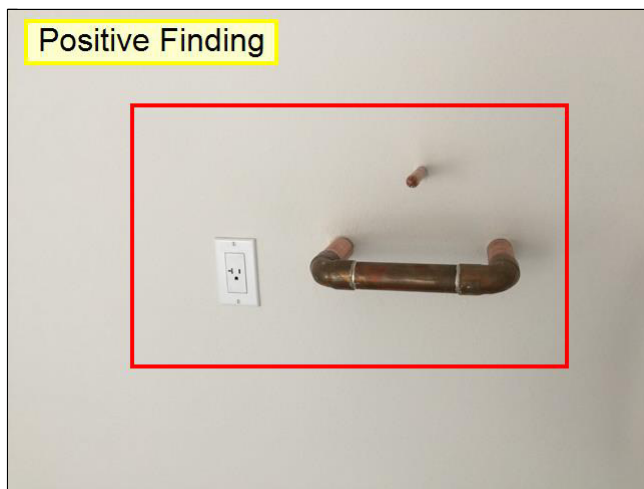
6.3 Item 3(Picture)

(3) Soft water loop present. This condition was observed in the garage. Refer to the photograph for further clarification. This is deemed to be a positive finding.

The client is advised that water softener systems can range in cost between \$500 and \$8000 with little difference provided with regards to water quality. Experiences shown that the Home Depot has a low salt use, high-efficiency unit called the water boss that is relatively inexpensive to purchase and maintain. Be sure to verify that any company you are considering using to install the components with the better Better Business Bureau of Southern Nevada (702-320-4500) and verify the company's reliability report. Client is further advised research licensing status of any contractor that may be retained to install the water softener with the state of Nevada contractors board 702-486-1100.

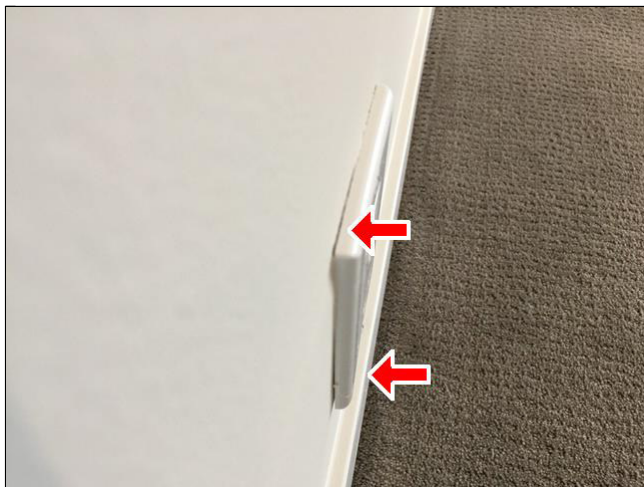
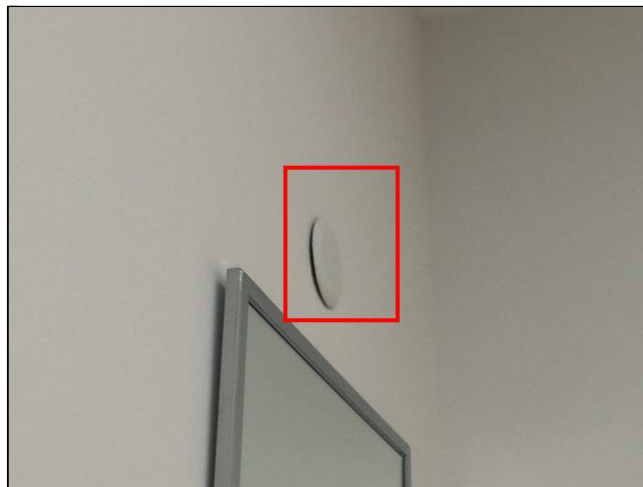
(1) ELECTRICAL RECEPTACLES OR SWITCHES STICK OUT FROM WALL SURFACE. This condition was observed in several locations. The photographs depicted are only representative photographs of this finding, Performance Guideline: All devices should fit snugly against the wall. It is recommended that this Finding and all associated components be reviewed and corrected by the Prime Contractor.

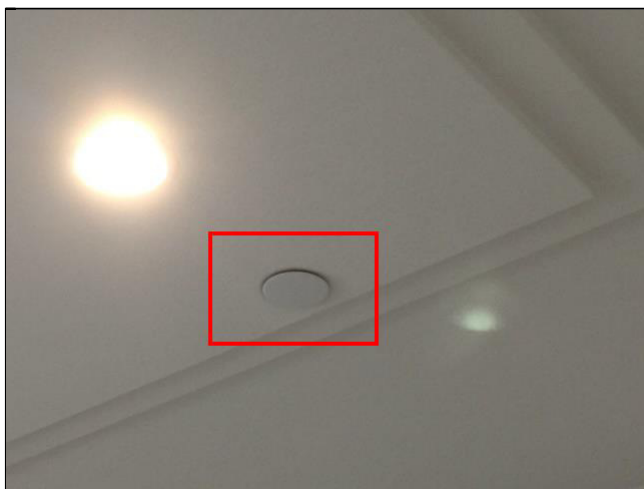
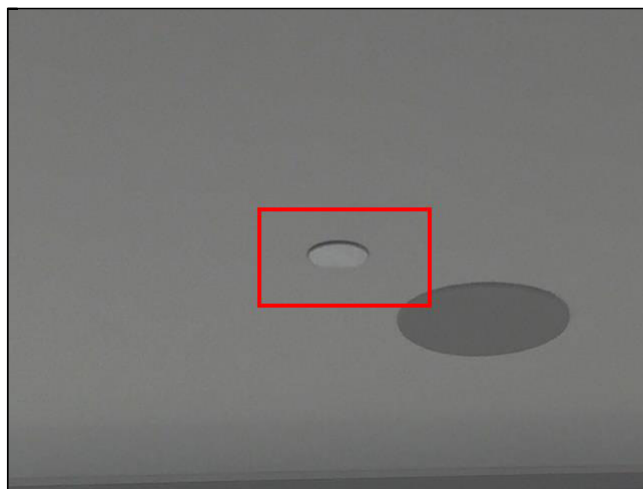
(2) Fire sprinkler cap gaped at ceiling. This condition was observed in several locations. The photographs depicted are only representative photographs of this finding. Performance guidelines: All devices should fit snugly against wall ceiling. It is recommended that this Finding and all associated components be reviewed and corrected by the Prime Contractor

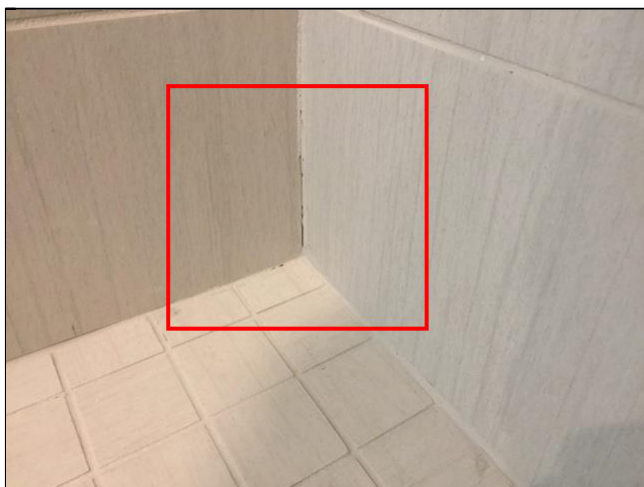
8.5 Item 1(Picture)

Grout amiss. This condition was observed in both bathrooms. The photographs depicted are only a representation of this finding. This Finding does not conform the minimum required workmanship or craftsmanship performance standards as defined by the SNHBA and affirmed by the Nevada State Contractors Board. It is recommended the Prime Contractor review this finding and correct as needed to conform with applicable building standards and practices.

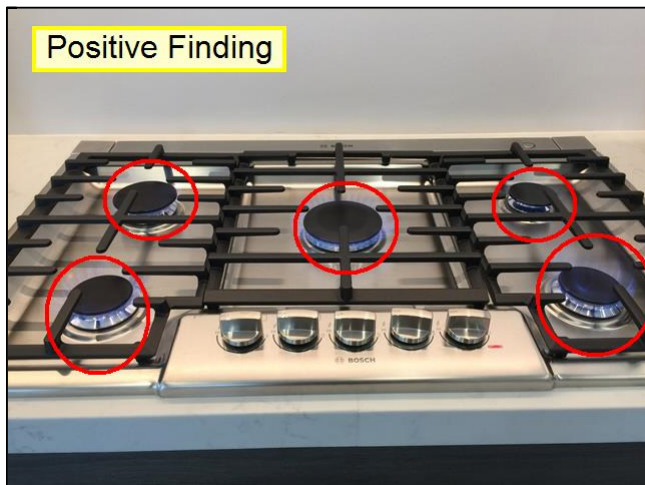
10.1 Item 1(Picture)

(1) Kitchen range burners operation verified. All of the burners on the kitchen range were tested. All of the burners ignited properly. This is a positive finding.

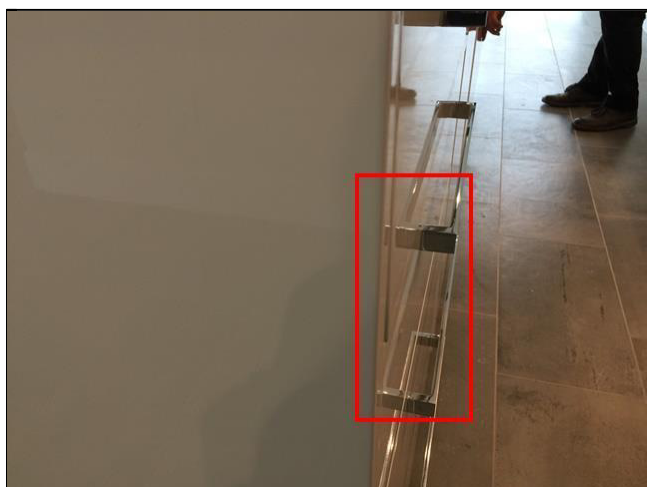
10.10 Item 1(Picture)

Cabinetry drawer issue. This condition was observed in several locations in the home. The photographs depicted are only representative photographs of this finding. This Finding does not conform the minimum required workmanship or craftsmanship performance standards as defined by the SNHBA and affirmed by the Nevada State Contractors Board. It is recommended the Prime Contractor review this finding and correct as needed to conform with applicable building standards and practices..

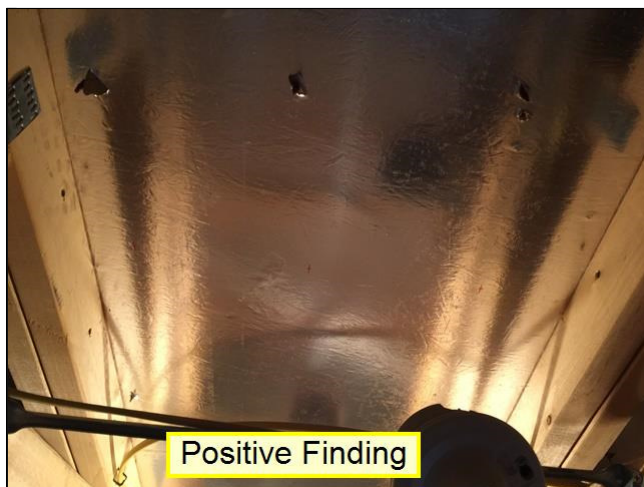
11.5 Item 1(Picture)

Aluminized roof sheathing (also known as a "radiant barrier") is generally an upgrade offered by home builders. The installation of this product is deemed a positive finding.

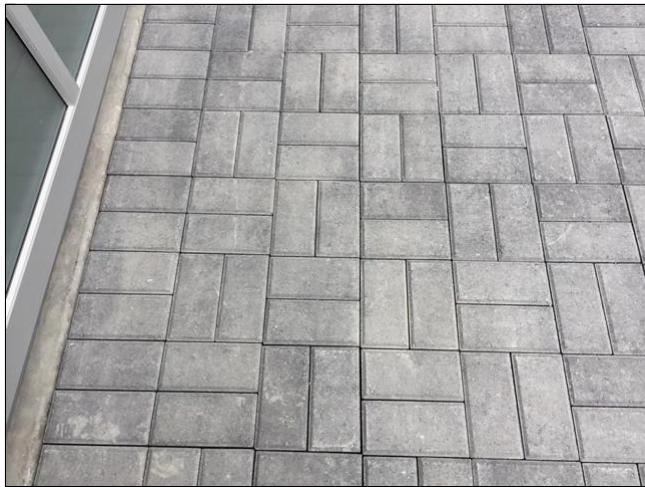
1.1 Item 1(Picture)

(1) Sand missing at paver blocks. This condition was observed at several locations around the structure. The photographs depicted are only representative photographs of this finding. Acceptable building standards state "Prior to final compaction of the surface, all joints should be filled with kiln dried fine jointing sand. All joints should remain full of jointing sand at all times, with periodic checking and re-sanding carried out where necessary." It is recommended that this Finding and all associated components be reviewed and corrected by the Prime Contractor.

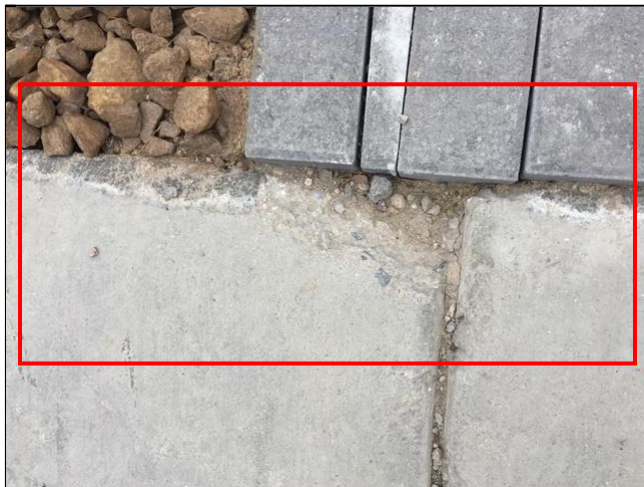
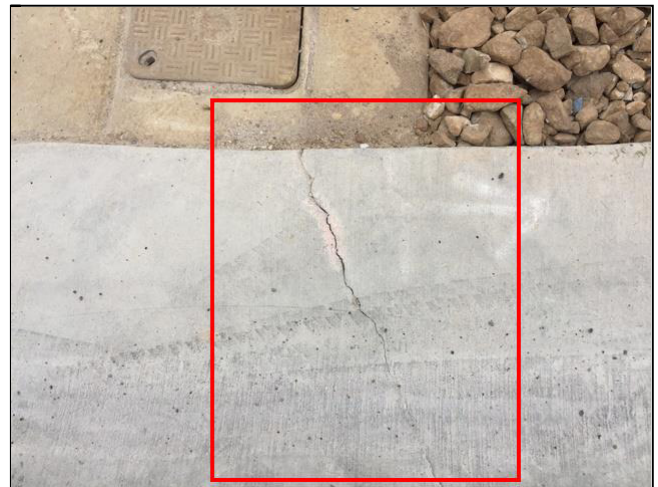
(2) Concrete cracks/damage observed. This condition was observed at the front of the property. The photographs depicted are only representative photographs of this finding. Left uncorrected this condition can result in accelerated deterioration. This Finding does not conform the minimum required workmanship or craftsmanship performance standards as defined by the SNHBA and affirmed by the Nevada State Contractors Board. " Concrete should not deteriorate to the extent that the aggregate is exposed or the aesthetics are destroyed under normal use and weather conditions." It is recommended the Prime Contractor review this finding and correct as needed to conform with applicable building standards and practices.

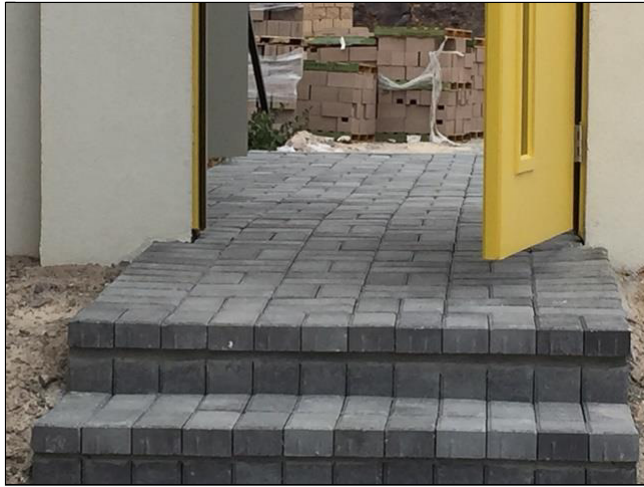
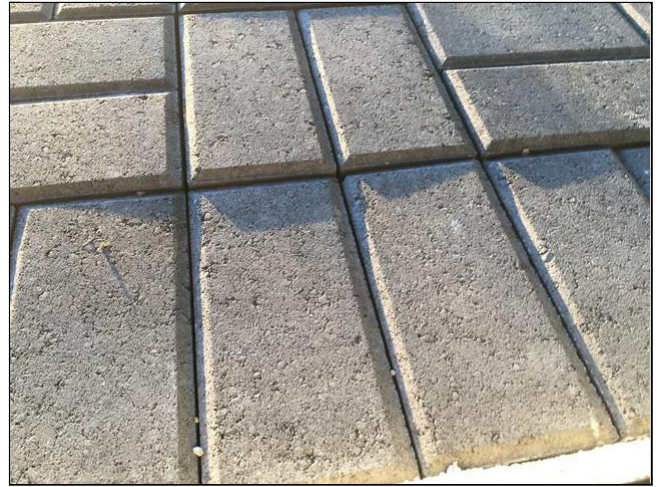
(3) Settling of paver blocks. This condition was observed at the front walkway and the rear patio. Refer to the photographs for further clarification. This Finding does not conform the minimum required workmanship or craftsmanship performance standards as defined by the SNHBA and affirmed by the Nevada State Contractors Board. Some settling of the masonry driveway / walkway should be expected. Settling or heaving in excess of a 1/4 inch is unacceptable. It is recommended the Prime Contractor review this finding and correct as needed to conform with applicable building standards and practices.

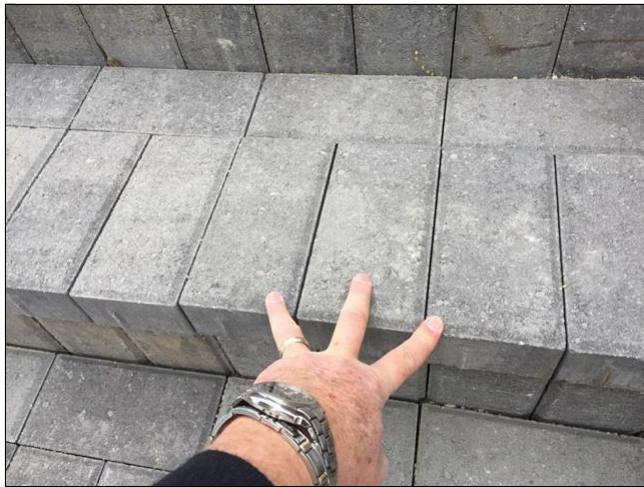
1.1 Item 10(Picture)

(4) Paver blocks loose. This condition was observed on the front walkway. The moving pavers can pose a trip hazard. This finding does not conform to building standards and practices in effect at the time of construction or installation. The photograph depicted is only a representative photographs of this finding. It is recommended that this Finding and all associated components be reviewed and corrected by the Prime Contractor.

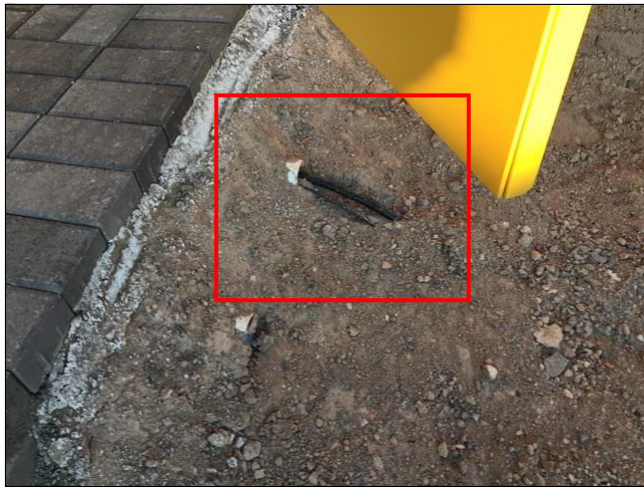
1.5 Item 1(Picture)

Irrigation pipeline unprotected where could be damaged, This condition was located in the court yard. This Finding does not conform the minimum required workmanship or craftsmanship performance standards. It is recommended the Prime Contractor review this finding and correct as needed to conform with applicable building standards and practices.

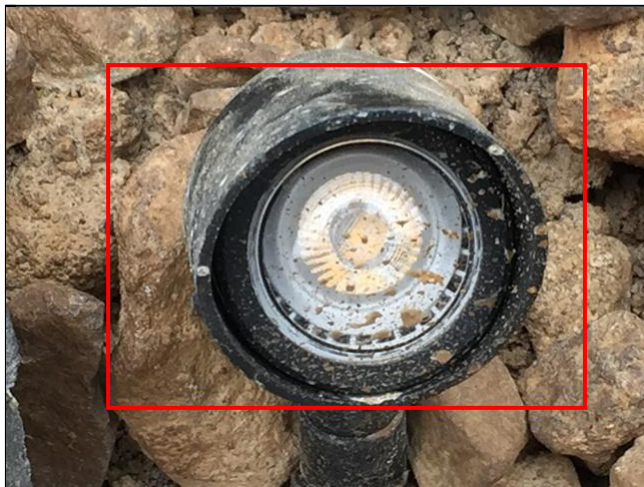
1.6 Item 1(Picture)

Landscaping / grounds lighting fixtures inoperative. This condition was observed on the front walkway. Refer to the photograph for further clarification. . This could be a faulty light bulb or the system may be inoperative. It is recommended that this Finding and all associated components be reviewed and corrected by the Prime Contractor.

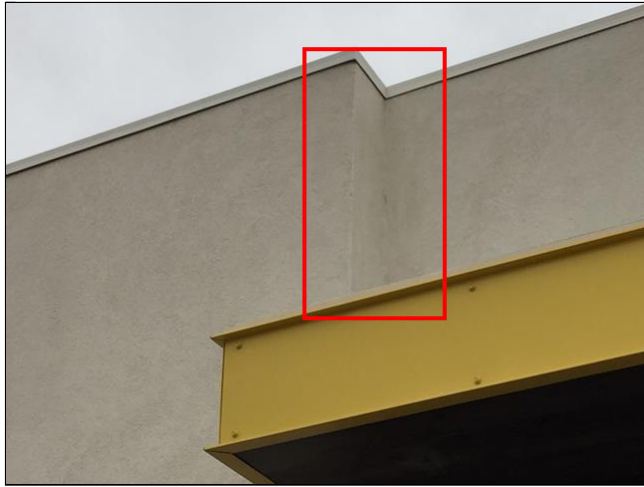
2.0 Item 1(Picture)

Siding amiss. This condition was observed on the South side of the structure. The photograph depicted is only a representative photograph of this finding. In accordance with Residential Construction Performance Standards stucco siding is required to present a uniform appearance when viewed under normal lighting conditions from a distance of 5 feet. The photographs depicted are only representative of this finding. It is recommended that this Finding and all associated components be reviewed and corrected by the Prime Contractor.

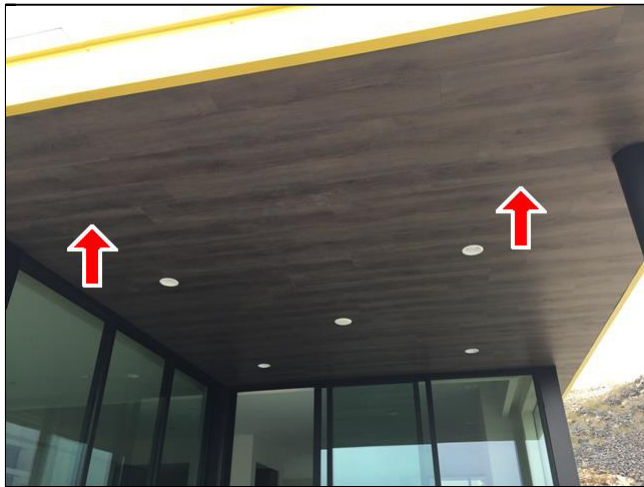
2.1 Item 1(Picture)

Vinyl laminate flooring use in soffit questionable. Refer to photographs for further clarification. Many manufactures take the stance that laminate flooring is not intended for outdoor use. There are some 'weather-resistant' laminates on the market, however most laminate floors are made strictly for indoor use. The flooring would warp and rapidly get damaged under changing weather conditions and would not last very long. Vinyl floor can be used in an outdoor, temperature controlled environment. This means that you can install vinyl flooring in a sun room, enclosed porch, or any other "outdoor" space where you can control the heat and cold. The manufacture of the product should be consulted as to the use in this manner and the installation instructions should be reviewed as to installation.

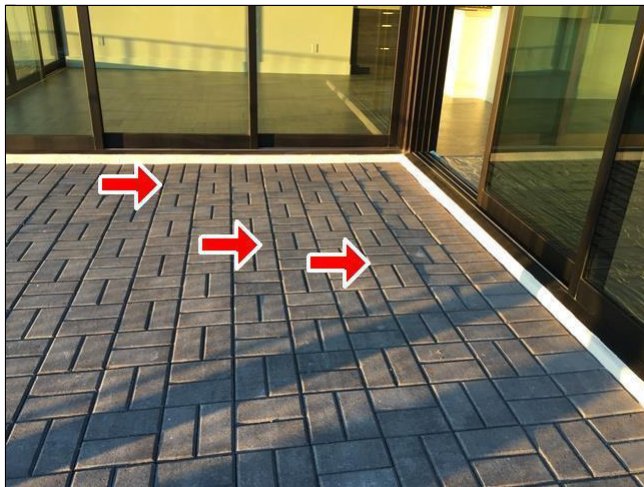
2.4 Item 1(Picture)

Improper drainage at rear patio. The pavers at the sliding glass doors are sloped into the building. The photographs depicted are only representative photographs of this finding. This Finding does not conform the minimum required workmanship or craftsmanship performance standards. It is recommended that this Finding and all associated components be reviewed and corrected by the Prime Contractor.

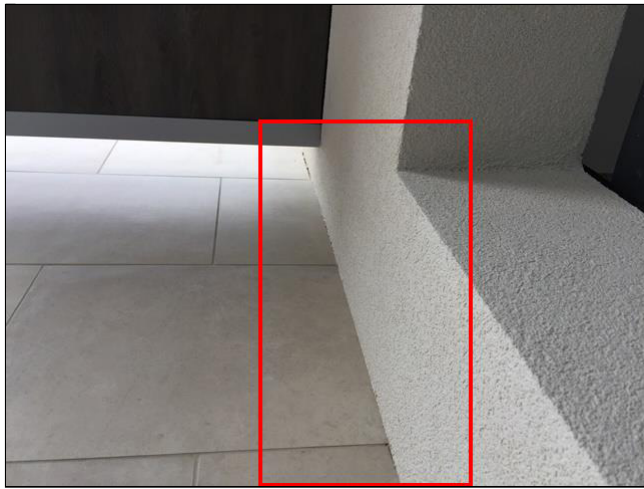
2.5 Item 1(Picture)

General caulking and sealing recommended. Caulk / sealing is needed at several locations around the structure. The photograph depicted is only a representative photograph of this finding. This finding does not conform to building standards and practices in effect at the time of construction or installation. It is recommended that this Finding and all associated components be reviewed and corrected by the Prime Contractor.

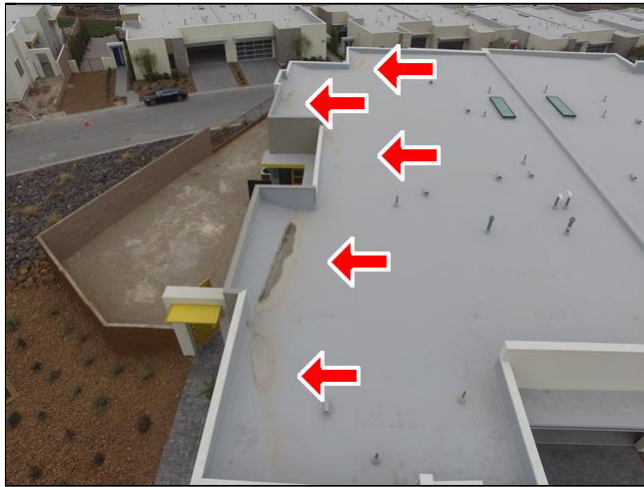
4.0 Item 1(Picture)

Pooling water appears to be observed on roof. Refer to photographs for further clarification. Nevada Contractors board states that " Roof sheathing should have a maximum deflection of 3/8 inch in 2 feet." This Finding does not conform the minimum required workmanship or craftsmanship performance standards as defined by the SNHBA and affirmed by the Nevada State Contractors Board. It is recommended the Prime Contractor review this finding and correct as needed to conform with applicable building standards and practices.

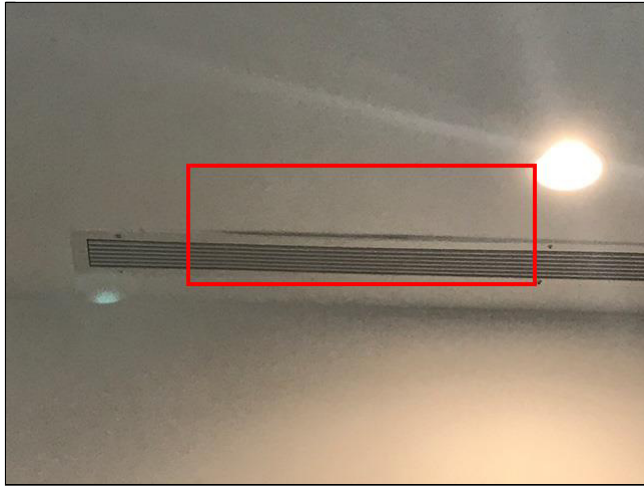
5.2 Item 1(Picture)

Register damaged. This condition was observed at the entry way. Refer to the photograph for further clarification. It is recommended that this Finding and all associated components be reviewed and corrected by the Prime Contractor.

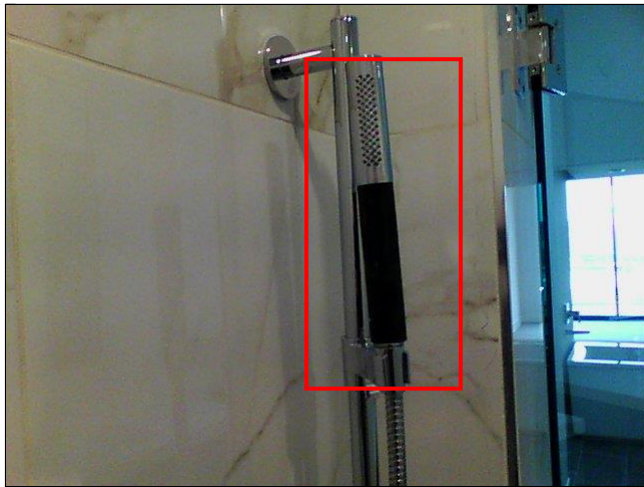
6.4 Item 1(Picture)

Water faucet leaking. This condition was observed at the hand wand in the master shower. Refer to the photographs for further clarification. Left uncorrected further accelerated deterioration will occur. This Finding does not conform the minimum required workmanship or craftsmanship performance standards as defined by the SNHBA and affirmed by the Nevada State Contractors Board. It is recommended the Prime Contractor review this finding and correct as needed to conform with applicable building standards and practices.

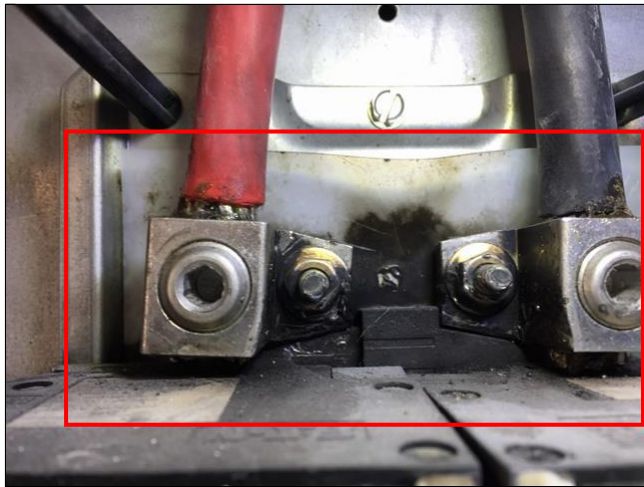
7.1 Item 1(Picture)

(1) Evidence of Electrical Flash in Sub Panel. This condition was observed in the garage. Refer to photograph for further clarification. It appears that there was an electrical short in the sub panel and the protective barrier has been damaged. It is recommended that this finding and all associated components be reviewed and corrected as needed by the primary contractor or a Licensed and Qualified Electrical Contractor.

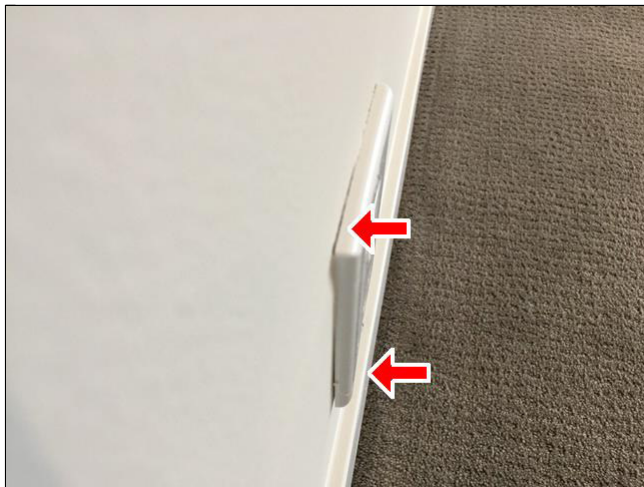
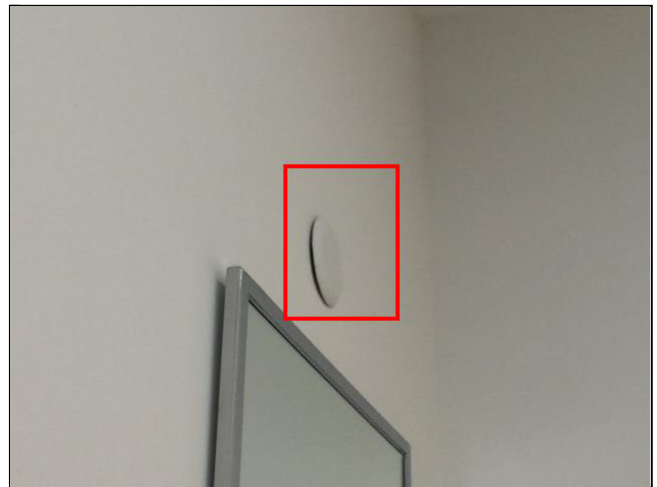
(1) ELECTRICAL RECEPTACLES OR SWITCHES STICK OUT FROM WALL SURFACE. This condition was observed in several locations. The photographs depicted are only representative photographs of this finding, Performance Guideline: All devices should fit snugly against the wall. It is recommended that this Finding and all associated components be reviewed and corrected by the Prime Contractor.

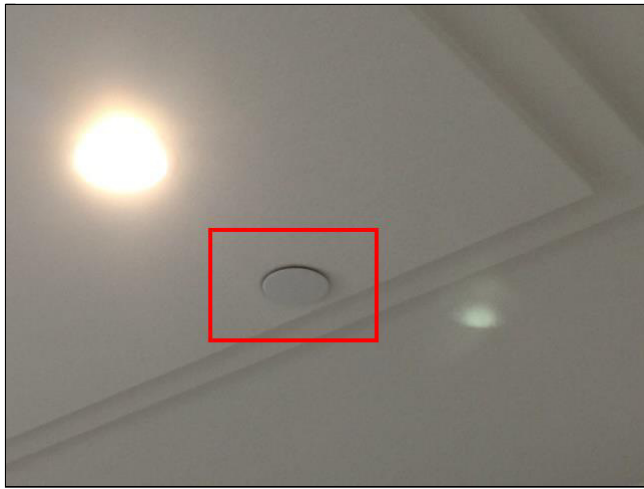
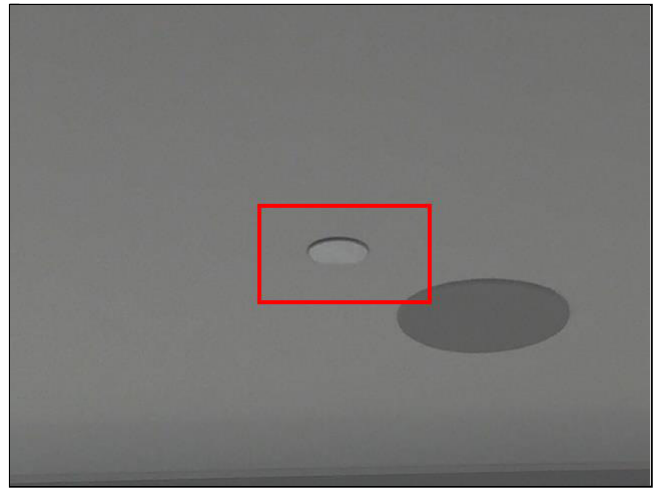
(2) Fire sprinkler cap gaped at ceiling. This condition was observed in several locations. The photographs depicted are only representative photographs of this finding. Performance guidelines: All devices should fit snugly against wall ceiling. It is recommended that this Finding and all associated components be reviewed and corrected by the Prime Contractor

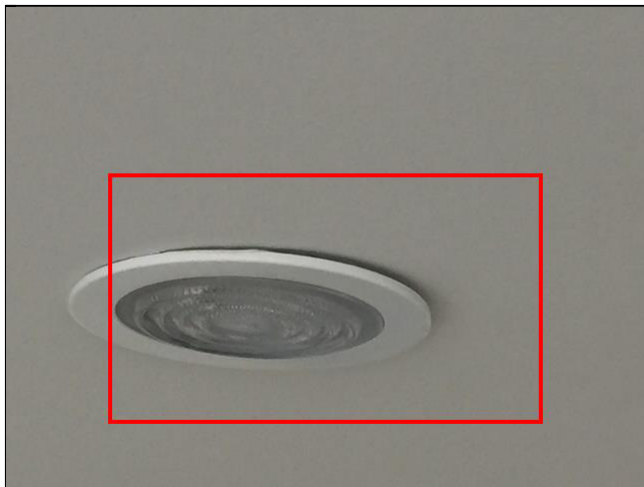
7.3 Item 5(Picture)

(3) Light fixture not secure. This condition was located at several locations around the structure. The photographs depicted are only representative photographs of this finding. Recessed light is not flush with the ceiling.. This Finding does not conform the minimum required workmanship or craftsmanship performance standards as defined by the SNHBA and affirmed by the Nevada State Contractors Board. It is recommended the Prime Contractor review this finding and correct as needed to conform with applicable building standards and practices.

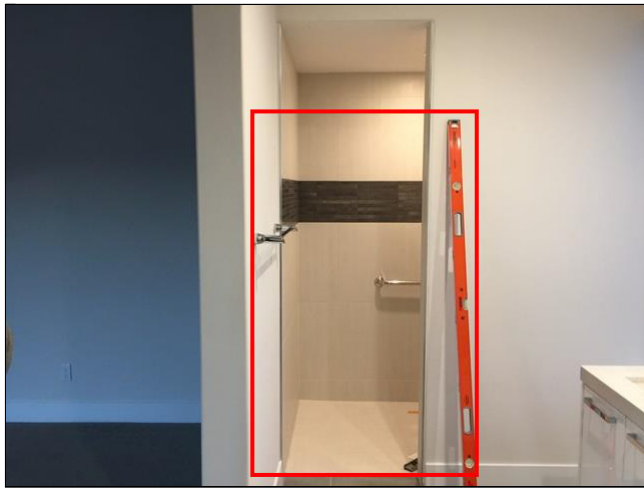
8.0 Item 1(Picture)

Curbless shower with no shower door. This condition was observed in the secondary bathroom. Refer to photograph for further clarification. There should be a shower door that goes to the floor with a sweep to help deflect water back into the shower for proper drainage. If there is to be a rod and curtain there should be a curb. This Finding does not conform the minimum required workmanship or craftsmanship performance standards. It is recommended that this Finding and all associated components be reviewed and corrected by the Prime Contractor.

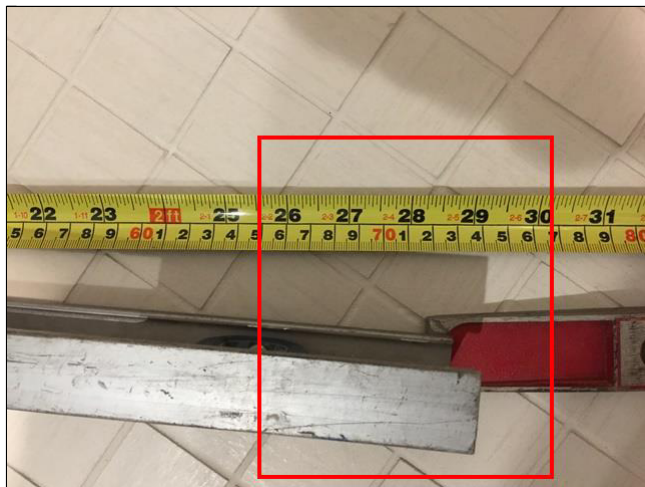
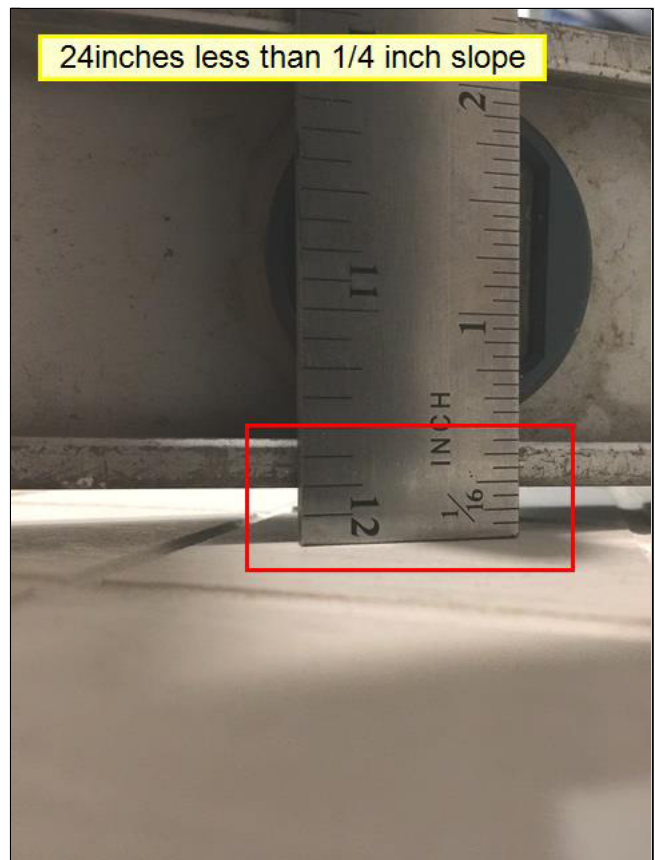
(2) Bathroom floor amiss. This condition was observed in the secondary bathroom shower. The photographs depicted are only representative photographs of this finding. The bathroom floor is improperly sloped. Standard building practices call for a minimum grade of 1/4 inch per lineal foot and a maximum grade of 1/2 inch per lineal foot. This Finding does not conform the minimum required workmanship or craftsmanship performance standards. It is recommended that this Finding and all associated components be reviewed and corrected by the Prime Contractor.

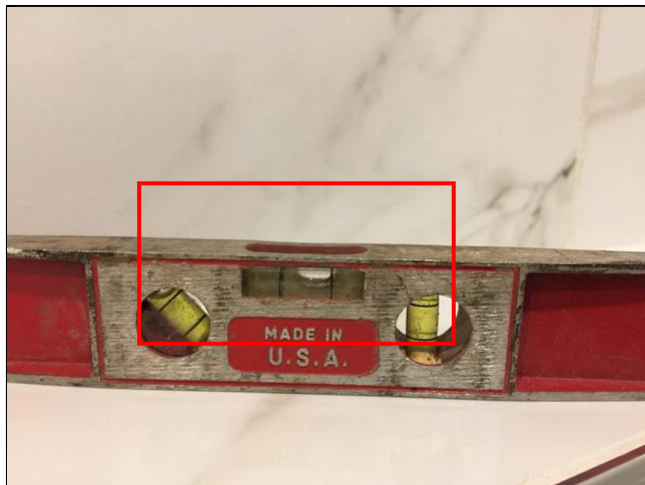
8.3 Item 6(Picture)

(3) Recessed shampoo / soap shelf in both master and secondary bathroom showers amiss. The recessed shelving area is improperly sloped. The photographs depicted are only representative photographs of this finding. The shelf should be sloped to shed water versus holding against the wall. This Finding does not conform the minimum required workmanship or craftsmanship performance standards. It is recommended that this Finding and all associated components be reviewed and corrected by the Prime Contractor.
