Inspection Report

Akamai Structural Inspector LLC

Date: 1/5/2019	Time: 09:00 AM	Report ID: 0105180900TLH
Property:	Customer:	Real Estate Professional:

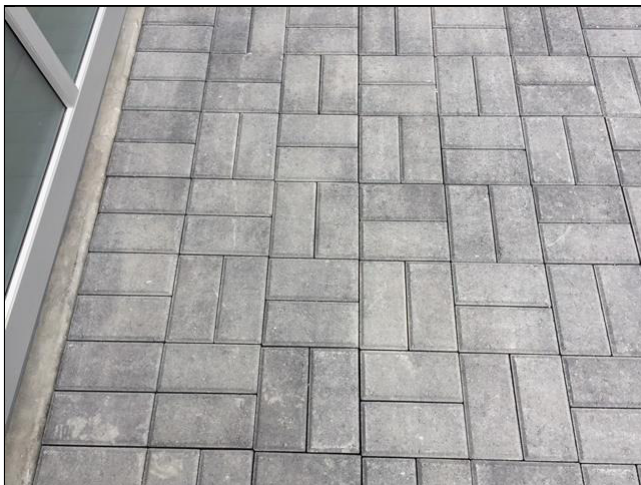
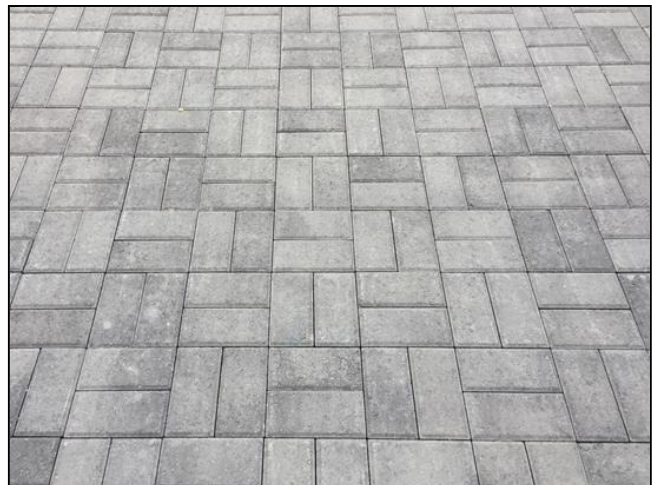
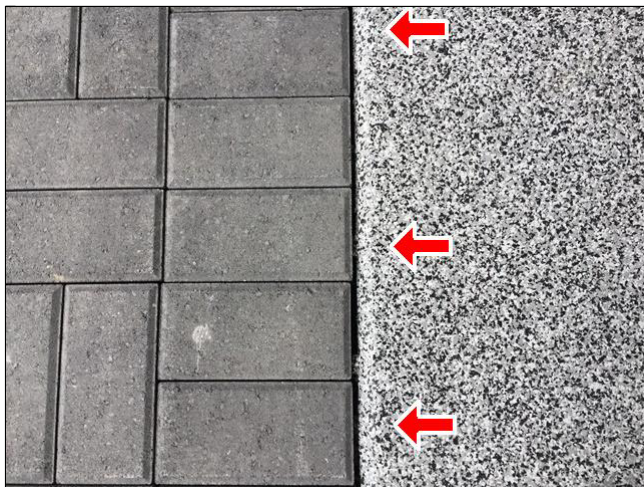
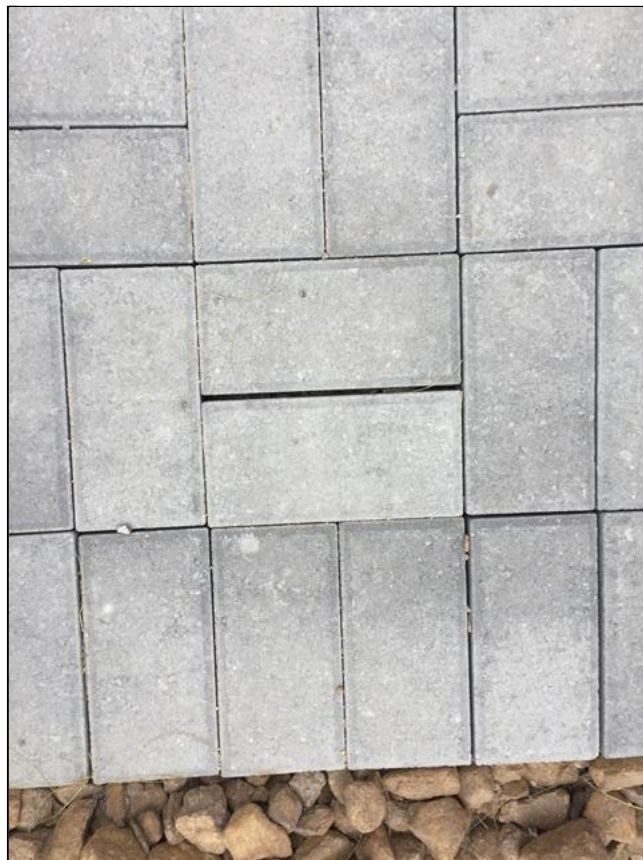
(1) Sand missing at paver blocks. This condition was observed at several locations around the structure. The photographs depicted are only representative photographs of this finding. Acceptable building standards state "Prior to final compaction of the surface, all joints should be filled with kiln dried fine jointing sand. All joints should remain full of jointing sand at all times, with periodic checking and re-sanding carried out where necessary." It is recommended that this Finding and all associated components be reviewed and corrected by the Prime Contractor.

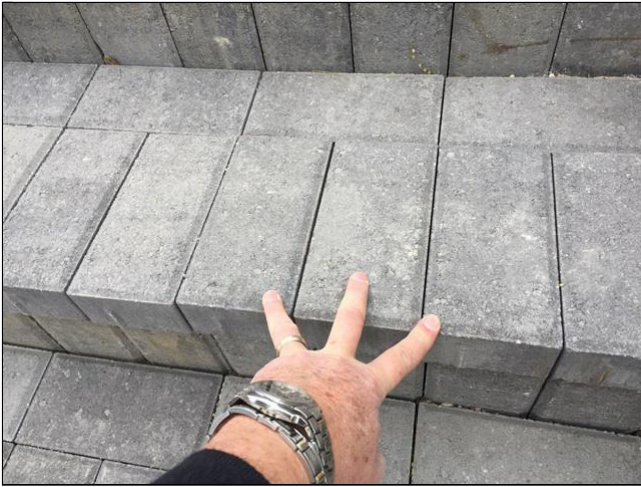
1.1 Item 10(Picture)

(4) Paver blocks loose. This condition was observed on the front walkway. The moving pavers can pose a trip hazard. This finding does not conform to building standards and practices in effect at the time of construction or installation. The photograph depicted is only a representative photographs of this finding. It is recommended that this Finding and all associated components be reviewed and corrected by the Prime Contractor.

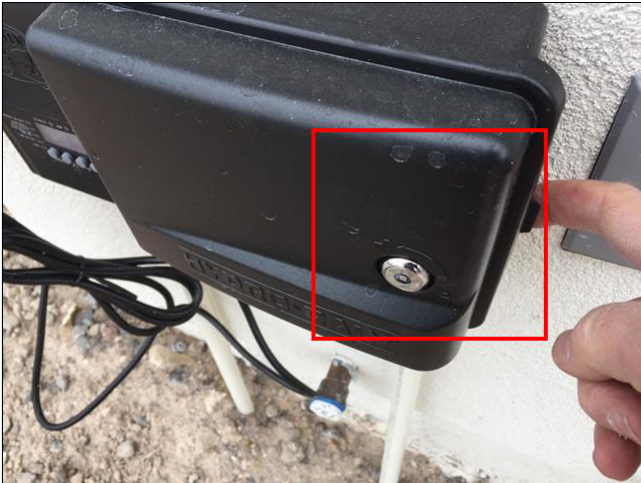
1.4 Item 1(Picture)

Access impaired. This condition was observed on the South side of the property. Refer to the photograph for further clarification. The controller was locked and the proper operation of the controller could not be observed. Further investigation is advised.

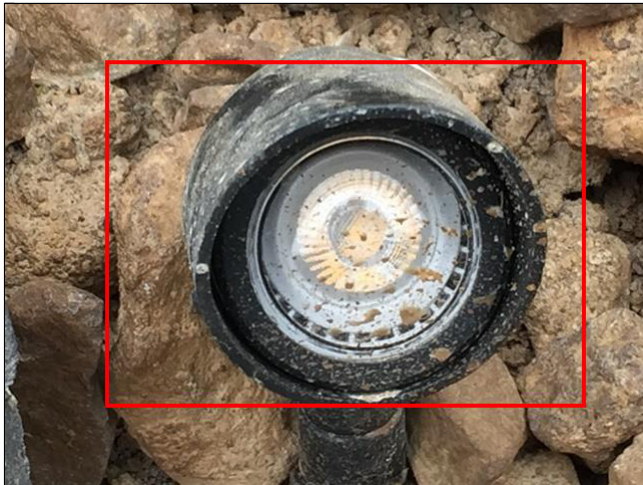
1.6 Item 1(Picture)

Landscaping / grounds lighting fixtures inoperative. This condition was observed on the front walkway. Refer to the photograph for further clarification. . This could be a faulty light bulb or the system may be inoperative. It is recommended that this Finding and all associated components be reviewed and corrected by the Prime Contractor.

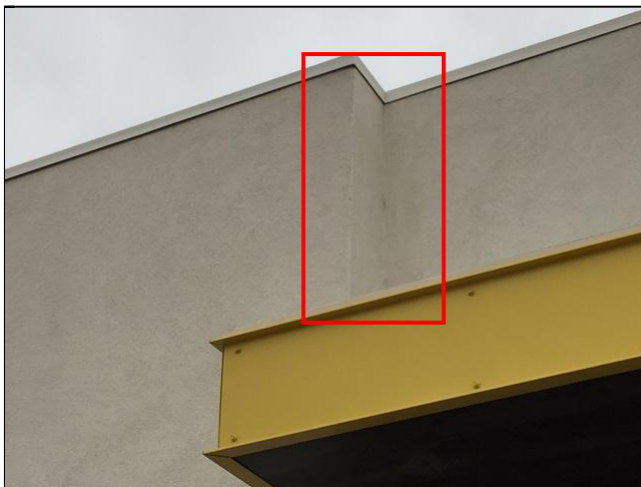
2.0 Item 1(Picture)

Siding amiss. This condition was observed on the South side of the structure. The photograph depicted is only a representative photograph of this finding. In accordance with Residential Construction Performance Standards stucco siding is required to present a uniform appearance when viewed under normal lighting conditions from a distance of 5 feet. The photographs depicted are only representative of this finding. It is recommended that this Finding and all associated components be reviewed and corrected by the Prime Contractor.

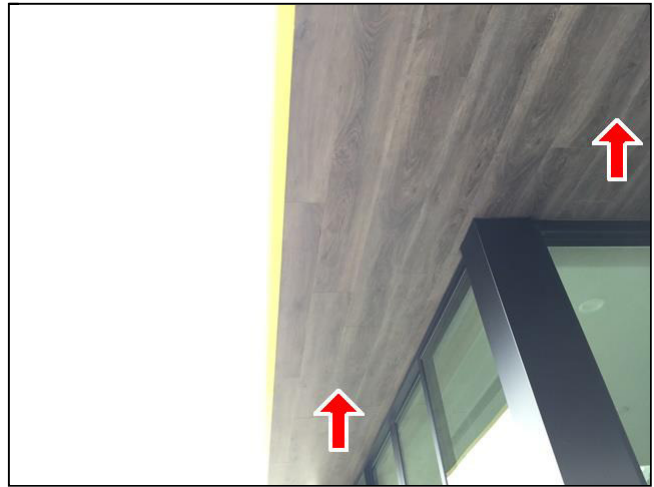
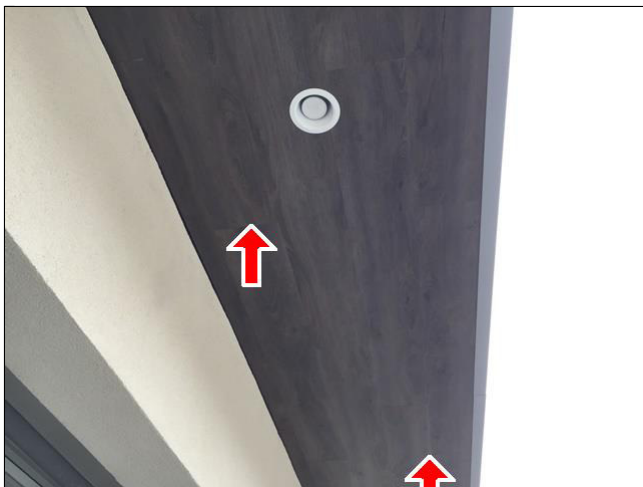
Vinyl laminate flooring use in soffit questionable. Refer to photographs for further clarification. Many manufactures take the stance that laminate flooring is not intended for outdoor use. There are some 'weather-resistant' laminates on the market, however most laminate floors are made strictly for indoor use. The flooring would warp and rapidly get damaged under changing weather conditions and would not last very long. Vinyl floor can be used in an outdoor, temperature controlled environment. This means that you can install vinyl flooring in a sun room, enclosed porch, or any other "outdoor" space where you can control the heat and cold. The manufacture of the product should be consulted as to the use in this manner and the installation instructions should be reviewed as to installation.

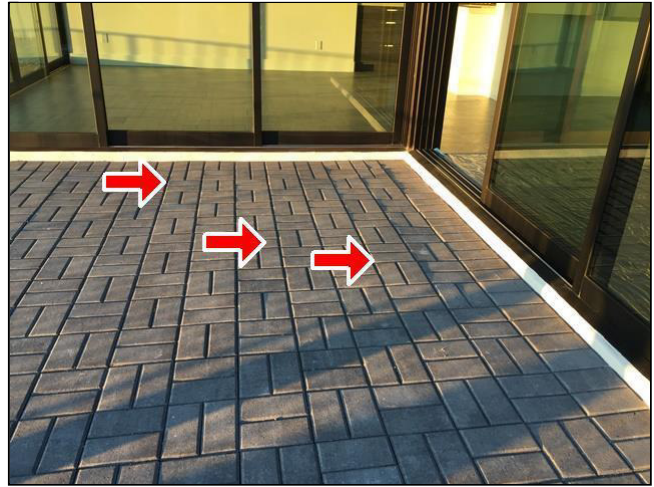
2.4 Item 2(Picture)

Improper drainage at rear patio. The pavers at the sliding glass doors are sloped into the building. The photographs depicted are only representative photographs of this finding. This Finding does not conform the minimum required workmanship or craftsmanship performance standards. It is recommended that this Finding and all associated components be reviewed and corrected by the Prime Contractor.

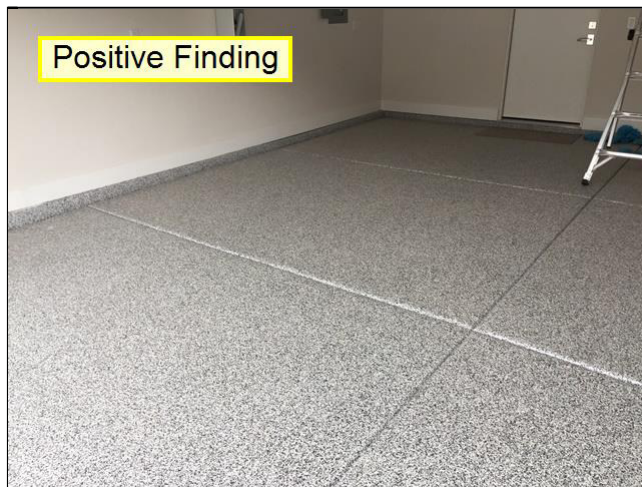
3.2 Item 1(Picture)

Garage floor paint. The photograph depicted is only a representative photograph of this finding. This is a positive finding.

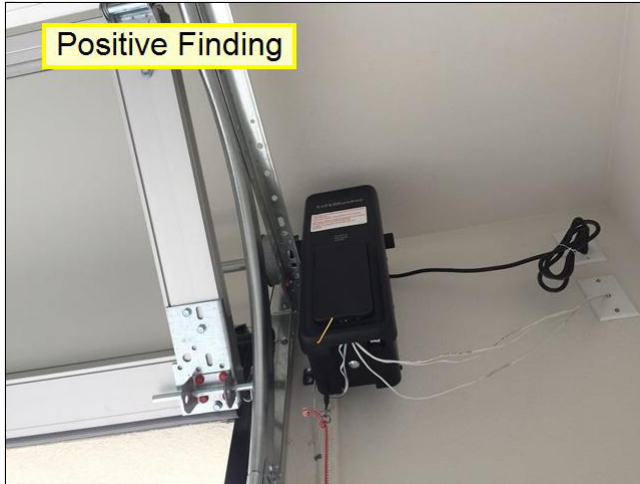
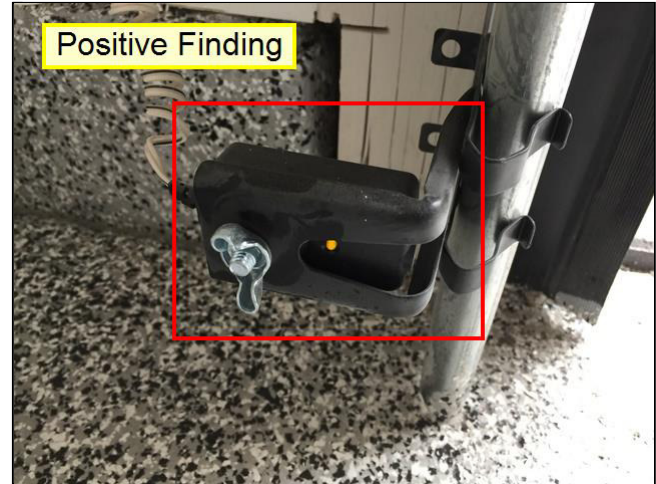
The garage door operator is equipped with two (2) types of safety reversing mechanisms. The first is a pressure tension safety reverse. The second is an electric eye safety reverse. Both of these safety features were reviewed and found to be operating as intended. This is a positive finding.

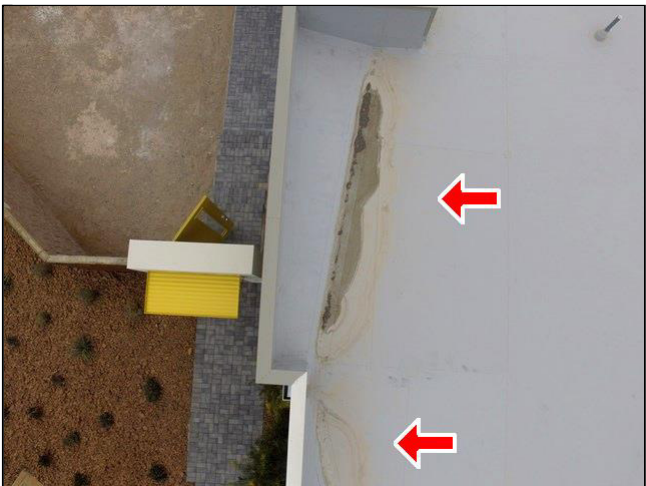
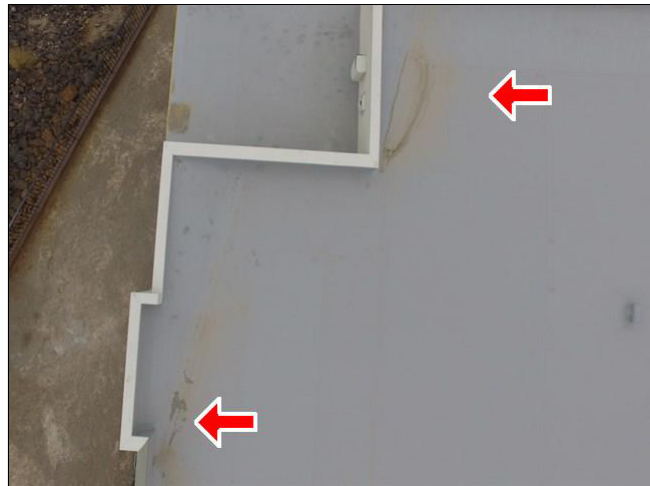
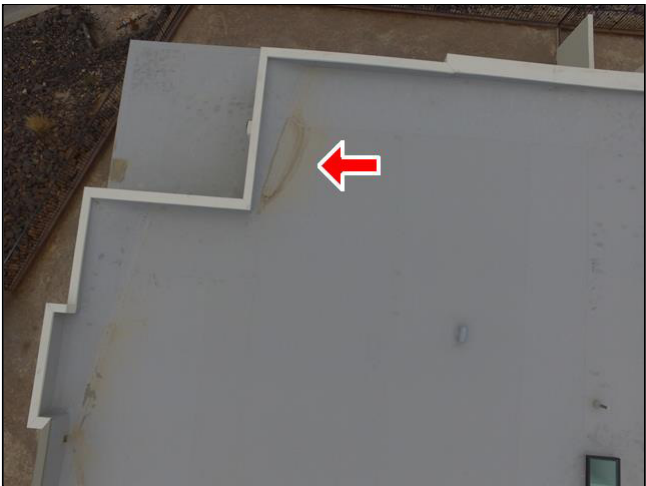
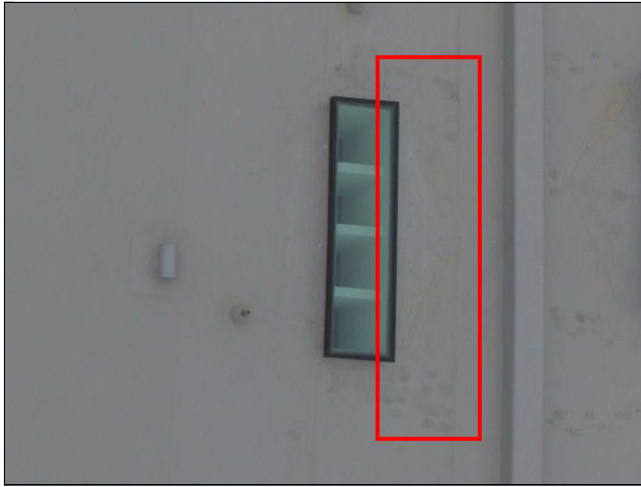
Pooling water appears to be observed on roof. Refer to photographs for further clarification. Nevada Contractors board states that " Roof sheathing should have a maximum deflection of 3/8 inch in 2 feet." This Finding does not conform the minimum required workmanship or craftsmanship performance standards as defined by the SNHBA and affirmed by the Nevada State Contractors Board. It is recommended the Prime Contractor review this finding and correct as needed to conform with applicable building standards and practices.

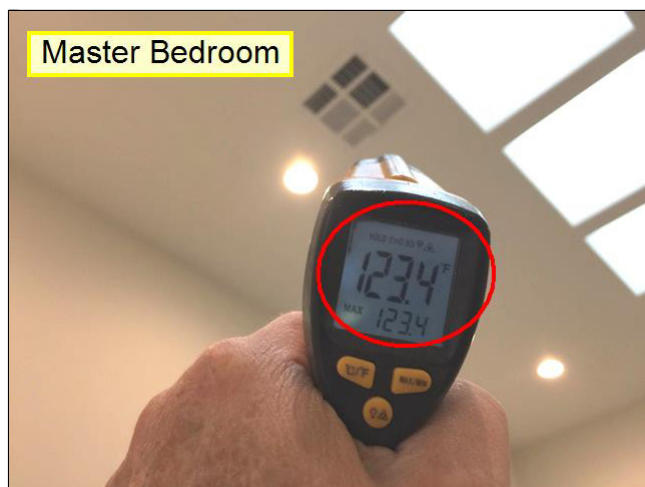
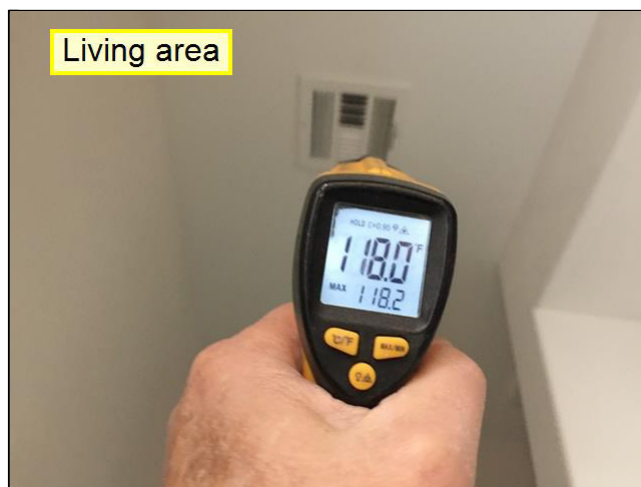
(1) The client is advised that the heating system(s) for the home was reviewed and the system operated properly when utilizing normal operating controls. This is deemed to be a positive finding.

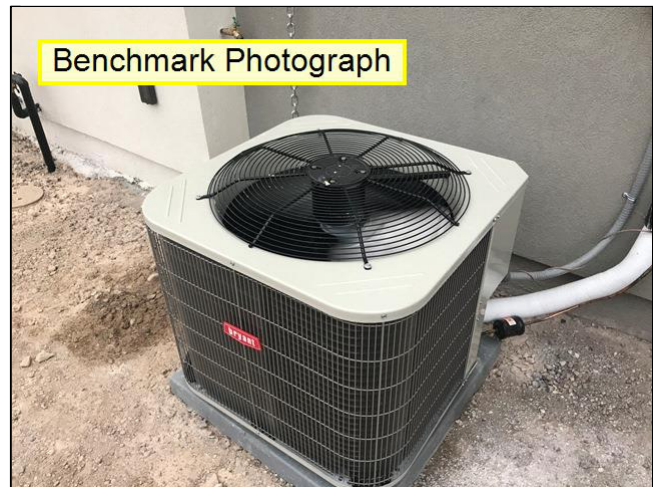
5.0 Item 4(Picture)

(2) Air conditioning testing limited. The client is advised that with exterior temperatures less than 65 degrees placing the air conditioner into normal operation can freeze the compressor and cause serious damage to the entire system. Operation of the systems at temperatures below 65 is advised against by many HVAC manufacturers. Below 65 degrees Fahrenheit the compressor(s) do not operate efficiently and often the temperature readings are inaccurate and representative of actual system operation. Your inspector briefly ran the system as a benchmark to show that the compressor activated and operated.

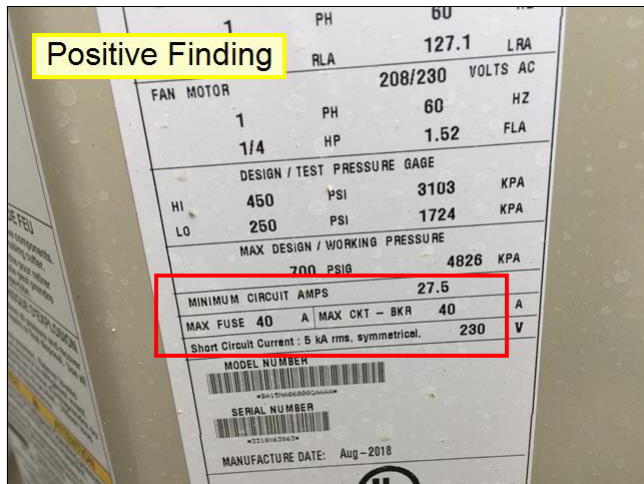
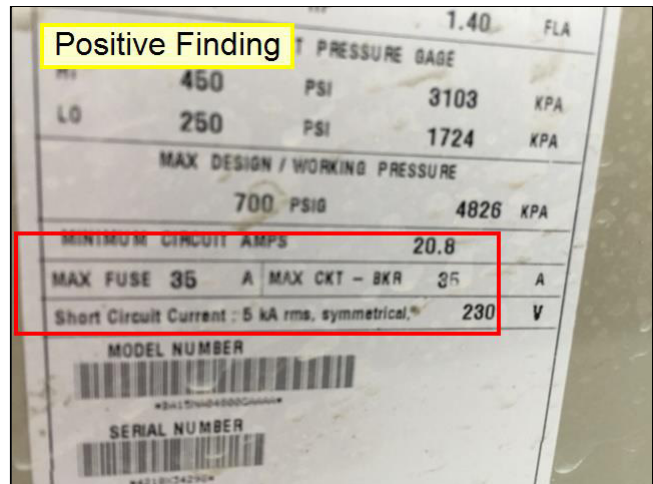
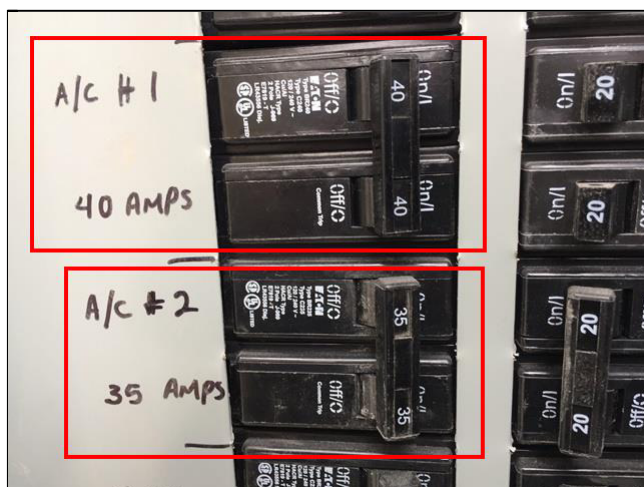
The electrical circuit breakers for the HVAC system condenser / compressor units were reviewed and compared against the size required to be installed as delineated by the manufacturers name plate data placard. It is very common to discover oversized breakers on air conditioner condenser / compressor units in Las Vegas. When this condition occurs it voids, not only the manufacturers warranty but any after-market home warranty. Therefore we inspect for this issue to provide our clients with an advanced level of protection. The breakers on the unit(s) in this system were verified to be properly sized. This is a positive finding.

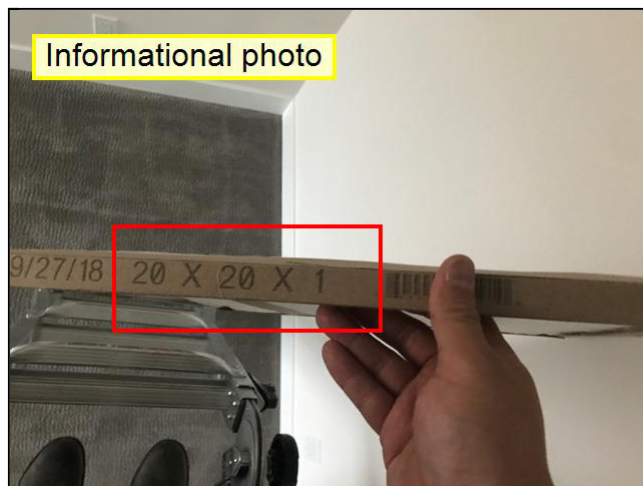
5.4 Item 2(Picture)

Filter size observed. This condition was observed both units in the home. The client is advised that the HVAC system for the home uses disposable filters. These filters should be replaced monthly. The correctly sized filter for the HVAC system is 20 x 20 x 1 and 20 x 25 x 1. 4 filter(s) required for a complete change out.

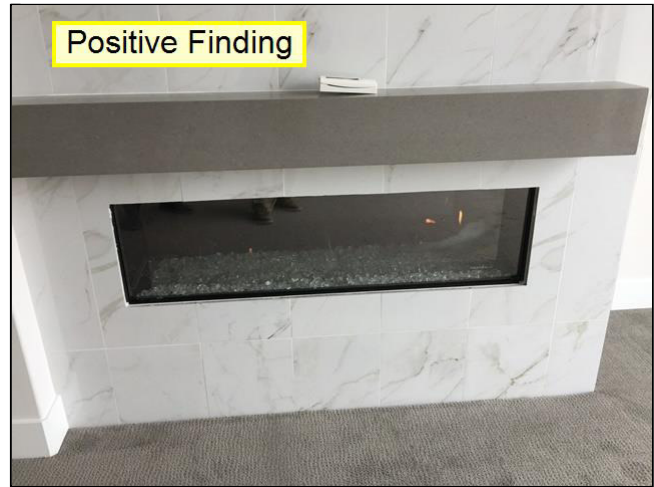
5.6 Item 2(Picture)

Fireplace operation verified. This condition was observed at both fireplaces in the home. The fireplace in the home was operated with no adverse conditions observed. The photograph depicted is only a representative photograph of the finding. This is deemed to be a positive finding.

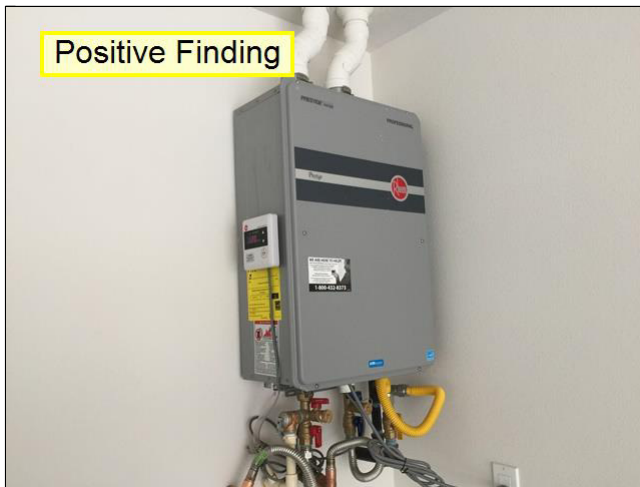
6.0 Item 1(Picture)

(1) Tankless water heater observed. This condition was observed in the garage. Refer to photograph for further clarification. This is a positive finding.

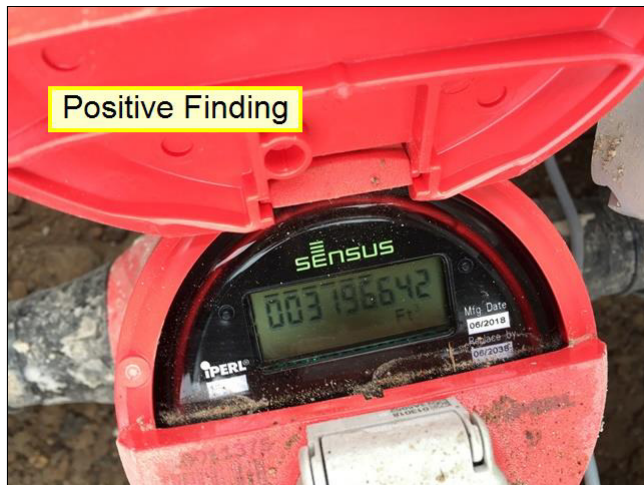
6.3 Item 1(Picture)

(1) Water meter reviewed. The client is advised that one of the first steps taken in the inspection is to mark and observed the flow indicator on the water meter for movement. Movement when all of the plumbing fixtures in the home are shut off is sometimes an indicator of a leak. No movement was observed at this meter. This is a positive Finding.

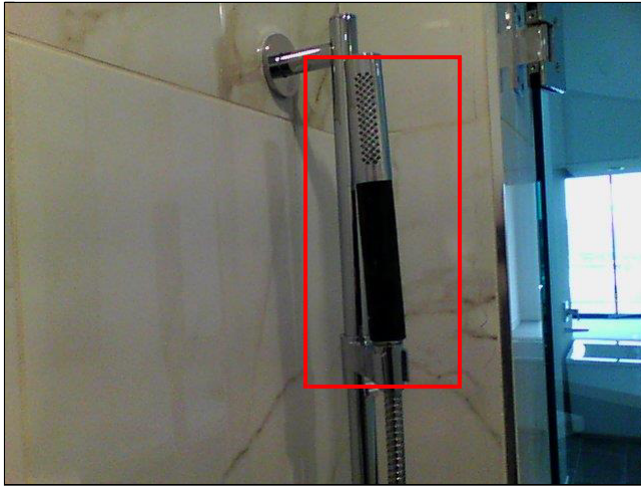
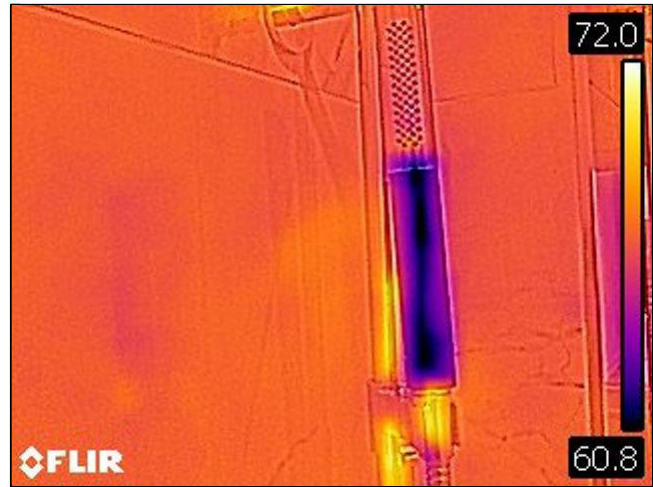
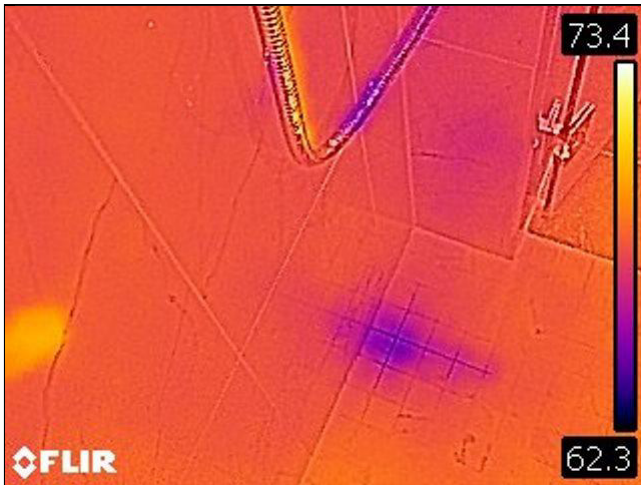
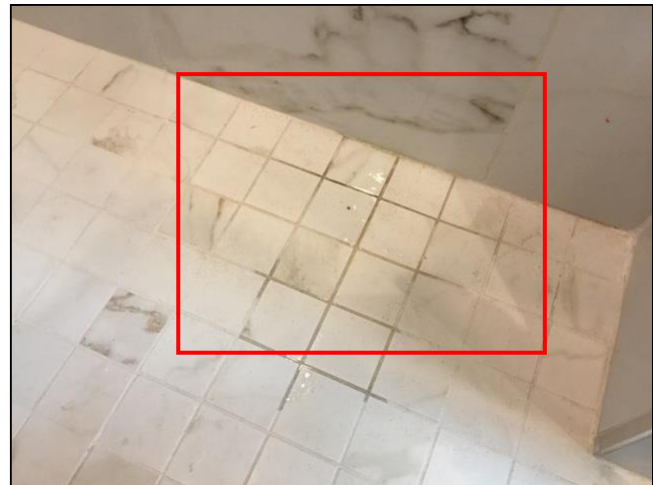
Water faucet leaking. This condition was observed at the hand wand in the master shower. Refer to the photographs for further clarification. Left uncorrected further accelerated deterioration will occur. This Finding does not conform the minimum required workmanship or craftsmanship performance standards as defined by the SNHBA and affirmed by the Nevada State Contractors Board. It is recommended the Prime Contractor review this finding and correct as needed to conform with applicable building standards and practices.

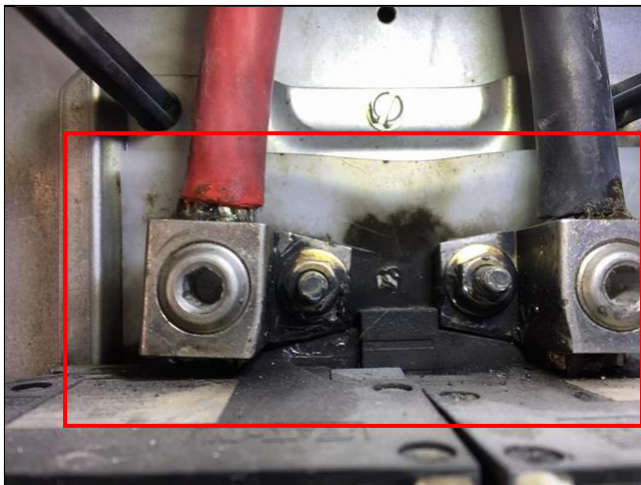
7.1 Item 1(Picture)

(1) Evidence of Electrical Flash in Sub Panel. This condition was observed in the garage. Refer to photograph for further clarification. It appears that there was an electrical short in the sub panel and the protective barrier has been damaged. It is recommended that this finding and all associated components be reviewed and corrected as needed by the primary contractor or a Licensed and Qualified Electrical Contractor.

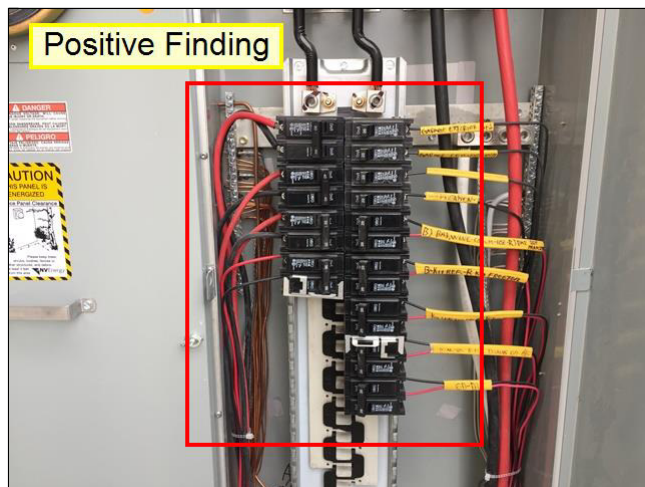
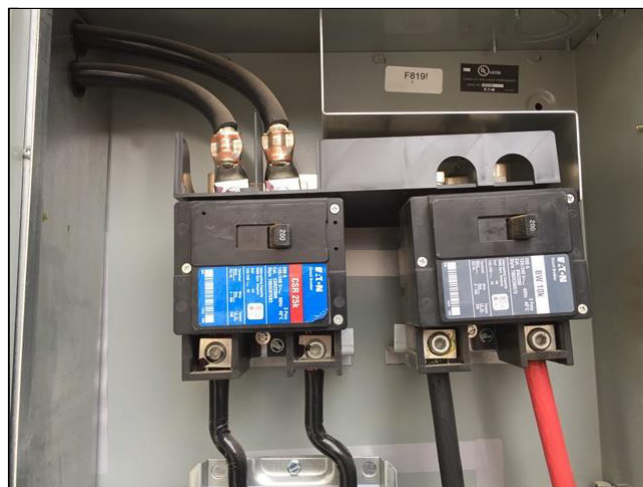
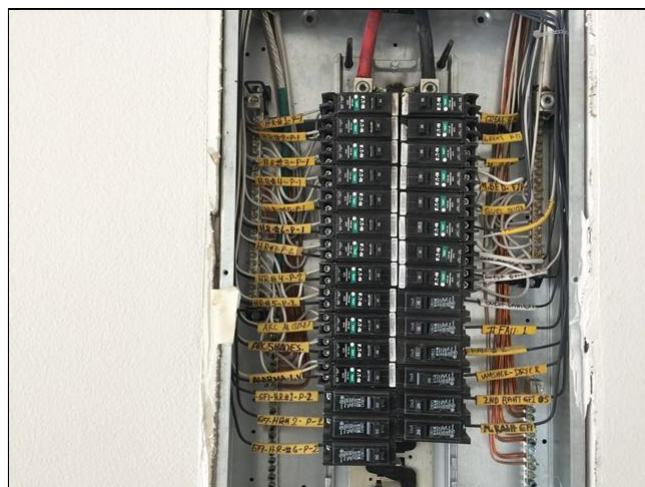
(2) Electrical panel is properly bonded and grounded. The electrical panel interior was fully reviewed for proper bonding and grounding. This is a positive finding.

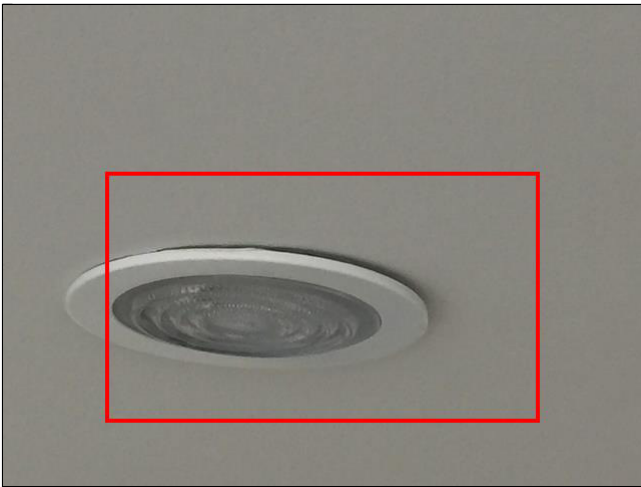
7.3 Item 5(Picture)

(3) Light fixture not secure. This condition was located at several locations around the structure. The photographs depicted are only representative photographs of this finding. Recessed light is not flush with the ceiling.. This Finding does not conform the minimum required workmanship or craftsmanship performance standards as defined by the SNHBA and affirmed by the Nevada State Contractors Board. It is recommended the Prime Contractor review this finding and correct as needed to conform with applicable building standards and practices.

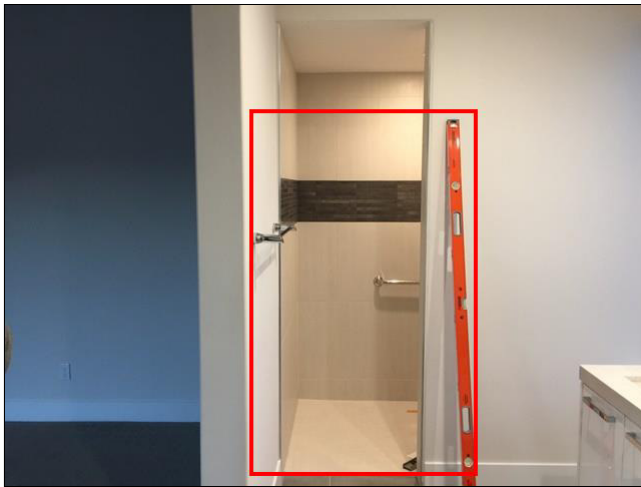
8.0 Item 1(Picture)

Curbless shower with no shower door. This condition was observed in the secondary bathroom. Refer to photograph for further clarification. There should be a shower door that goes to the floor with a sweep to help deflect water back into the shower for proper drainage. If there is to be a rod and curtain there should be a curb. This Finding does not conform the minimum required workmanship or craftsmanship performance standards. It is recommended that this Finding and all associated components be reviewed and corrected by the Prime Contractor.

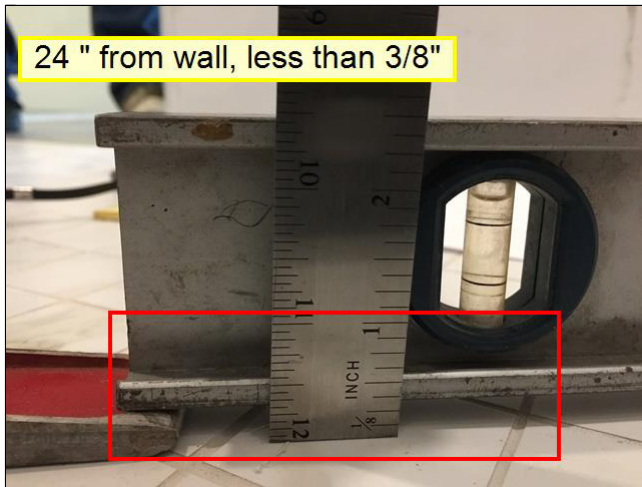
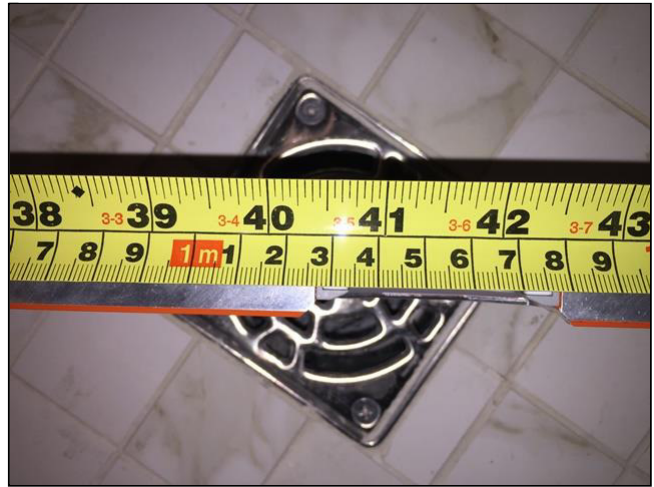
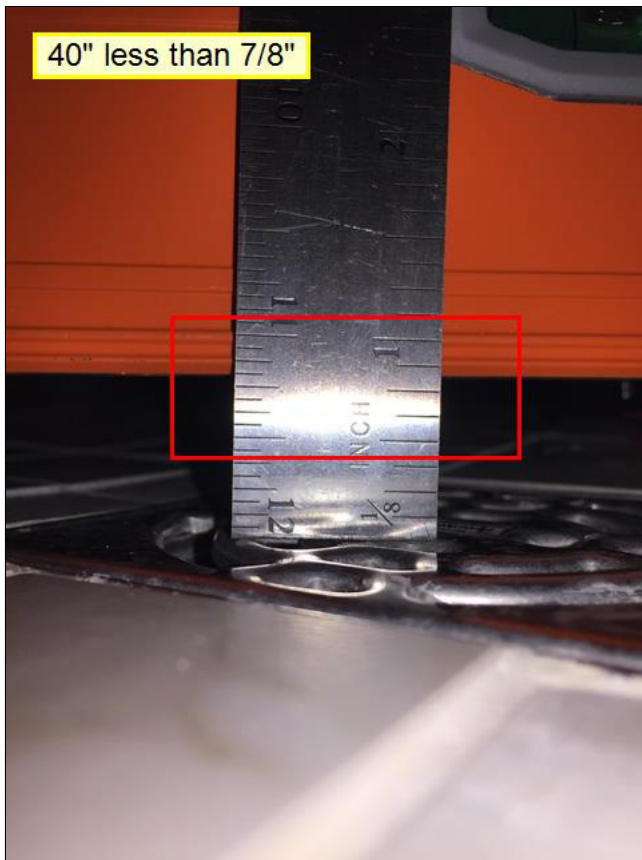
(1) Bathroom floor amiss. This condition was observed in the master bathroom shower. The photographs depicted are only representative photographs of this finding. The bathroom floor is improperly sloped. Standard building practices call for a minimum grade of 1/4 inch per lineal foot and a maximum grade of 1/2 inch per lineal foot. This Finding does

not conform the minimum required workmanship or craftsmanship performance standards. It is recommended that this Finding and all associated components be reviewed and corrected by the Prime Contractor.

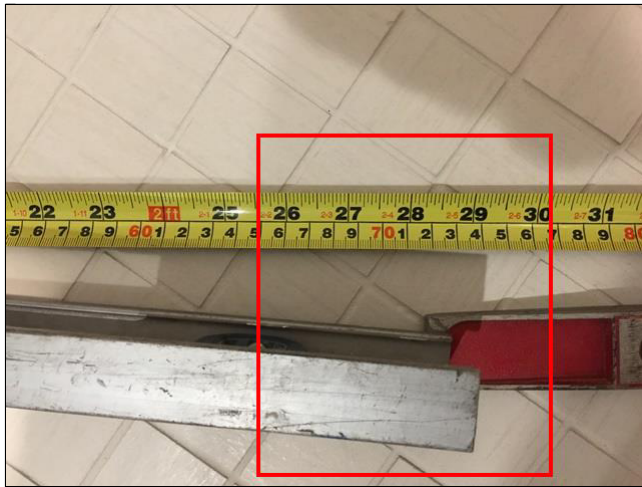
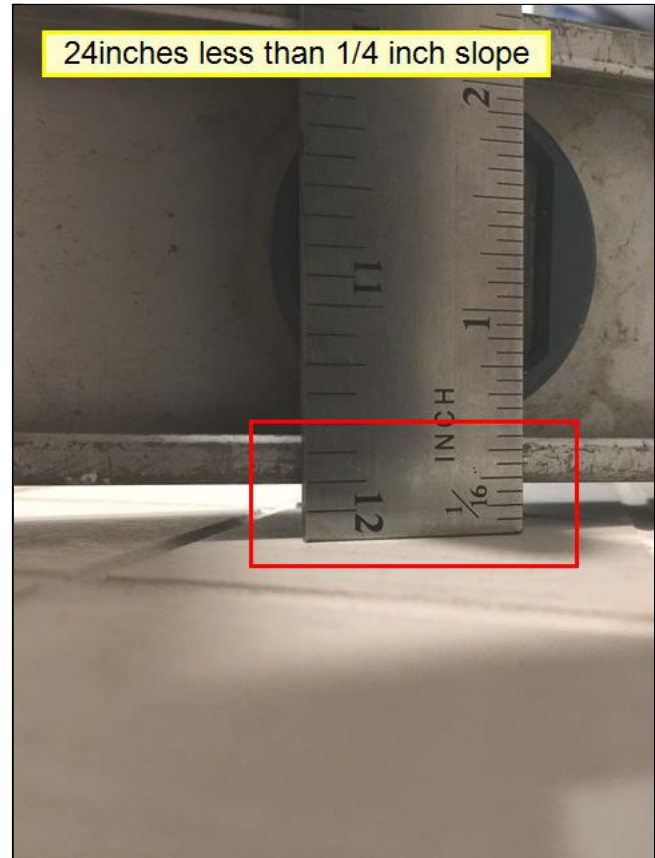
(2) Bathroom floor amiss. This condition was observed in the secondary bathroom shower. The photographs depicted are only representative photographs of this finding. The bathroom floor is improperly sloped. Standard building practices call for a minimum grade of 1/4 inch per lineal foot and a maximum grade of 1/2 inch per lineal foot. This Finding does not conform the minimum required workmanship or craftsmanship performance standards. It is recommended that this Finding and all associated components be reviewed and corrected by the Prime Contractor.

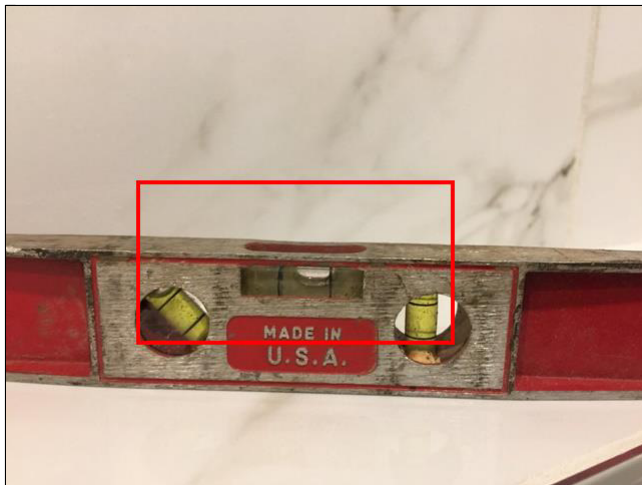
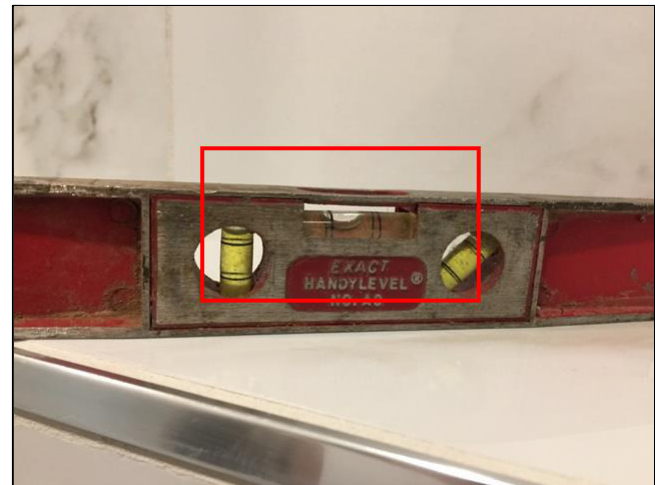
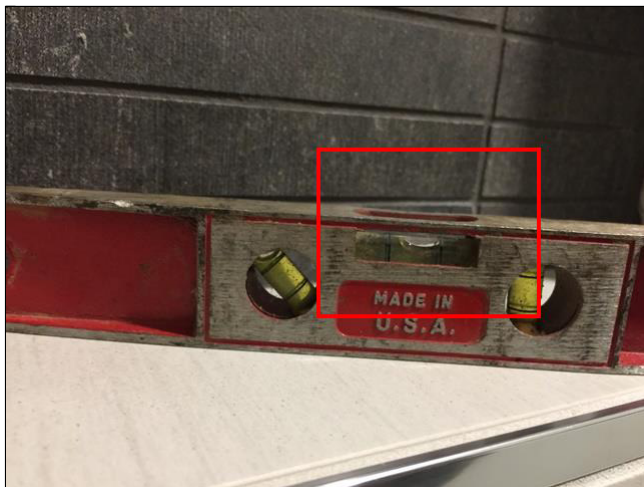
(3) Recessed shampoo / soap shelf in both master and secondary bathroom showers amiss. The recessed shelving area is improperly sloped. The photographs depicted are only representative photographs of this finding. The shelf should be sloped to shed water versus holding against the wall. This Finding does not conform the minimum required workmanship or craftsmanship performance standards. It is recommended that this Finding and all associated components be reviewed and corrected by the Prime Contractor.

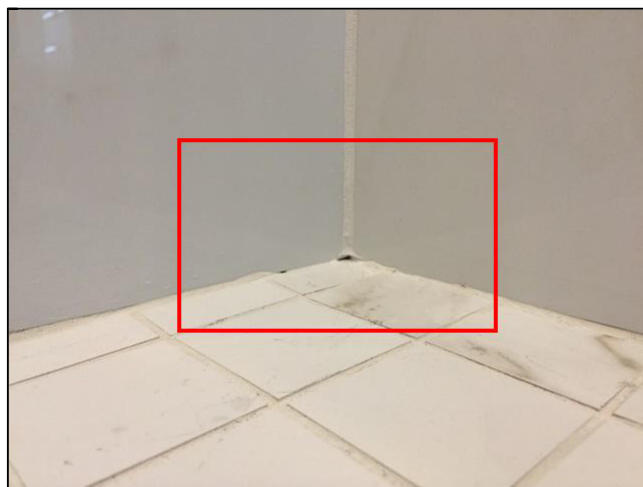
8.5 Item 2(Picture)

Grout amiss. This condition was observed in both bathrooms. The photographs depicted are only a representation of this finding. This Finding does not conform the minimum required workmanship or craftsmanship performance standards as defined by the SNHBA and affirmed by the Nevada State Contractors Board. It is recommended the Prime Contractor review this finding and correct as needed to conform with applicable building standards and practices.

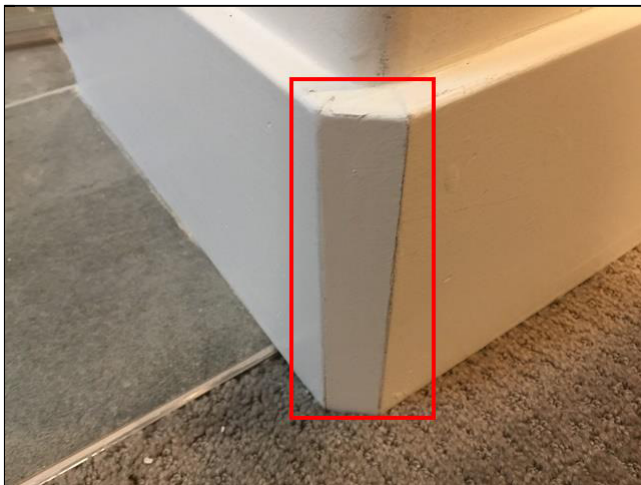
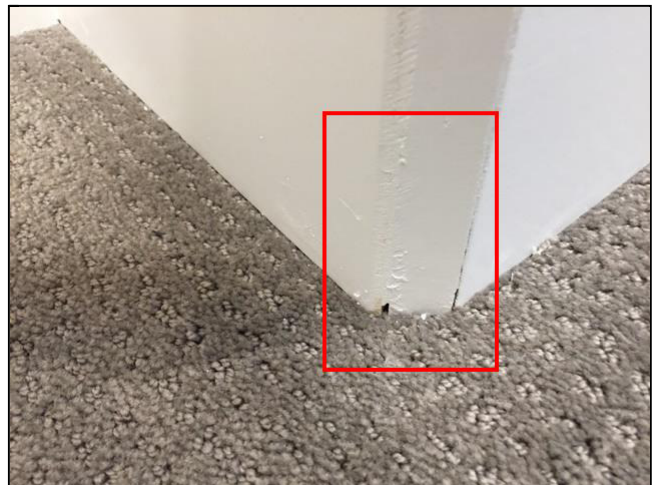
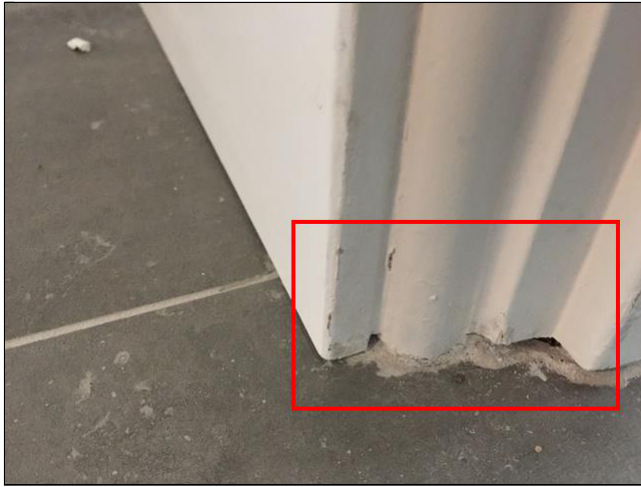
(1) Interior trim gaped This condition was observed in several locations in the home The photographs depicted are only representative photographs of this finding. This Finding does not conform the minimum required workmanship or craftsmanship performance standards as defined by the SNHBA and affirmed by the Nevada State Contractors Board. It is recommended the Prime Contractor review this finding and correct as needed to conform with applicable building standards and practices.

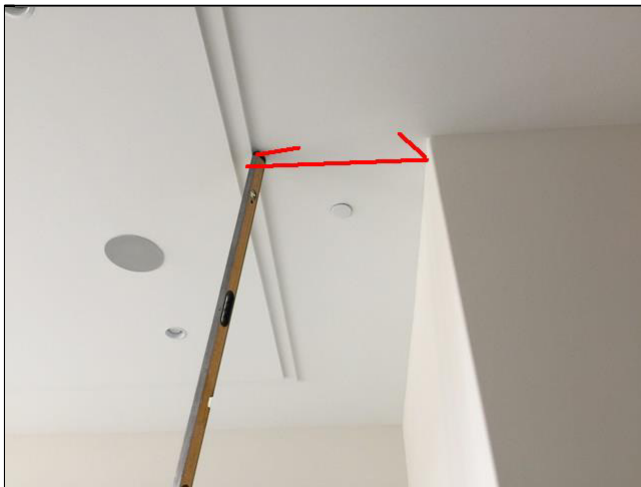
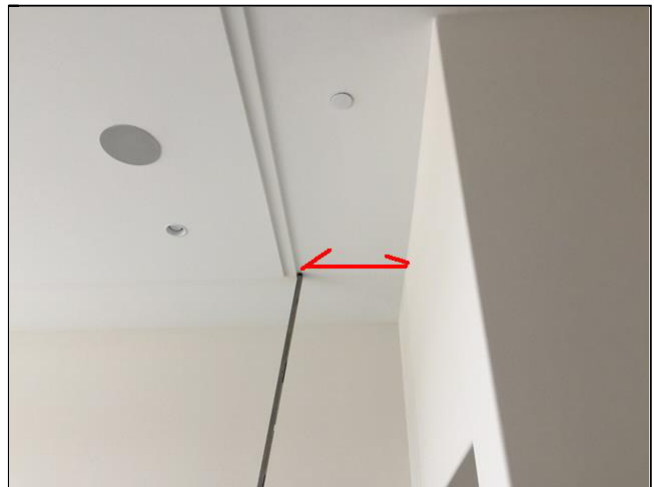
(2) CEILINGS THAT ARE OUT OF LEVEL OR SQUARE

Performance Guideline: Unevenness of floors or ceilings should not exceed 1/8 inch in 4 feet and should be level within 1/4 inch in 10 feet. This Finding does not conform the minimum required workmanship or craftsmanship performance standards as defined by the SNHBA and affirmed by the Nevada State Contractors Board. It is recommended the Prime Contractor review this finding and correct as needed to conform with applicable building standards and practices.

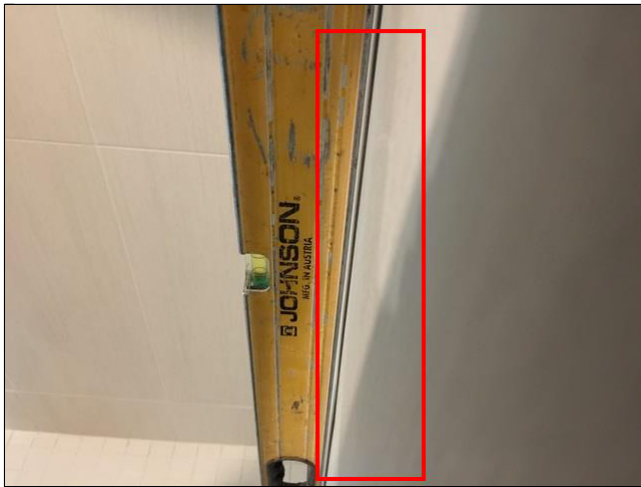
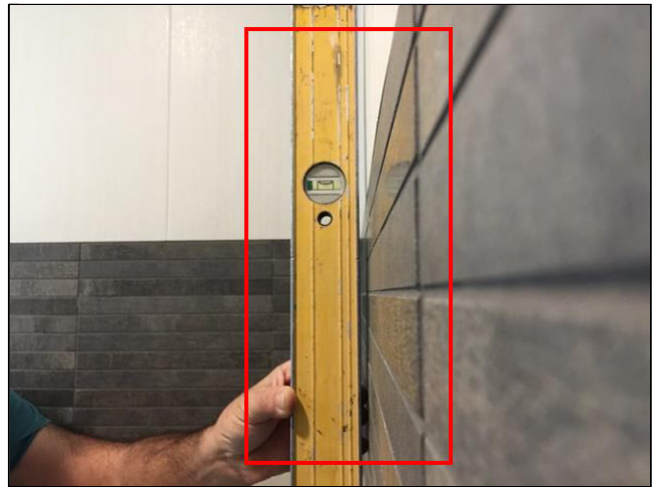
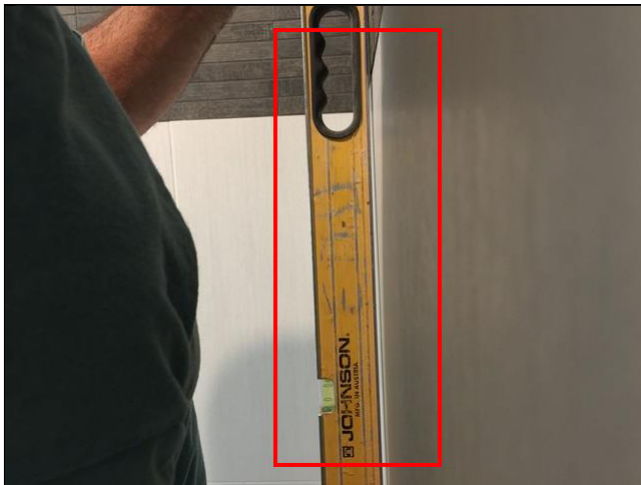
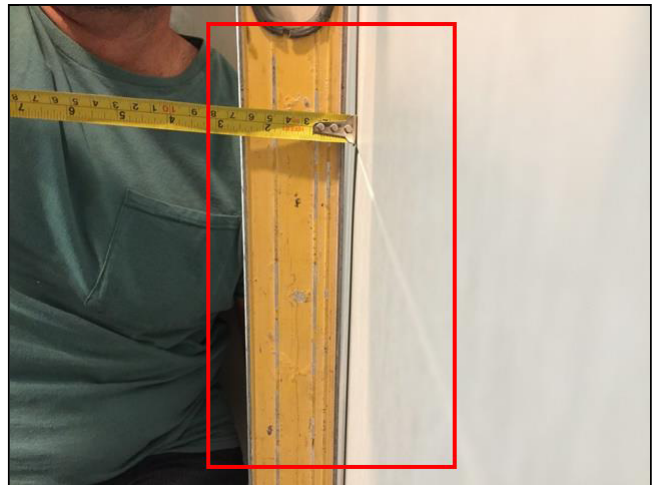
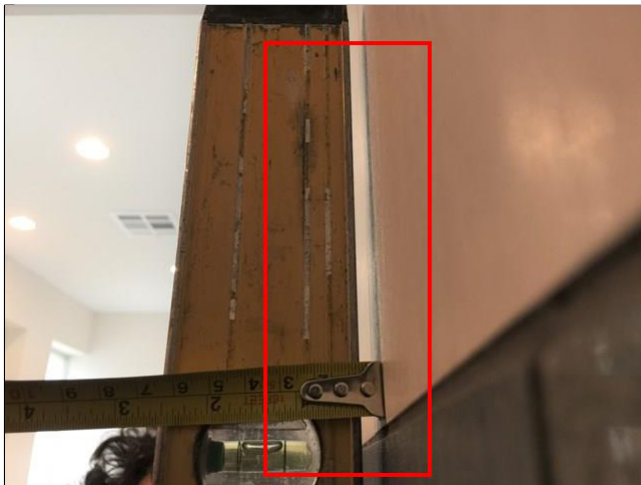
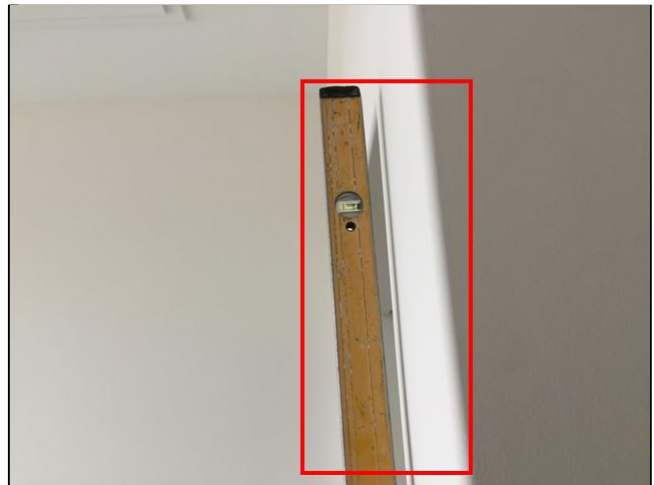
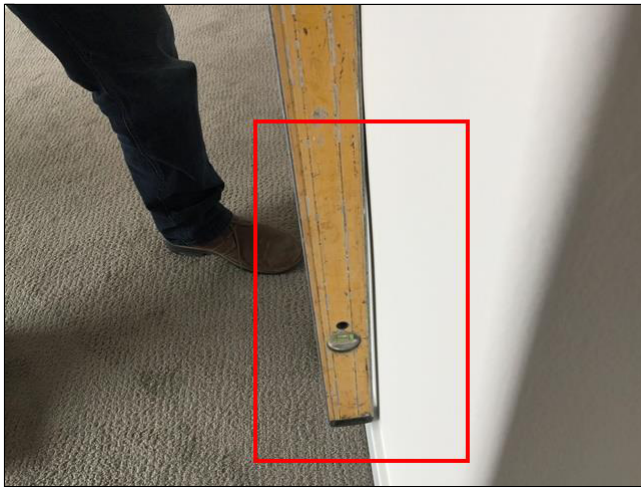
(3) Walls out of plumb. This condition was observed in several areas of the home. The photographs depicted are only a representation of this finding. United Facilities Guide Specification (UFGS) suggests a tolerance of 1/4" in 8' for plumbness of studs when finishes such as wallboard, plaster or ceramic tile set in a mortar bed are used. It is recommended that this Finding and all associated components be reviewed and corrected by the Prime Contractor.
