Inspection Report

Akamai Structural Inspector LLC

Date: 1/5/2019	Time: 09:00 AM	Report ID: 0105180900TLH
Property:	Customer:	Real Estate Professional:

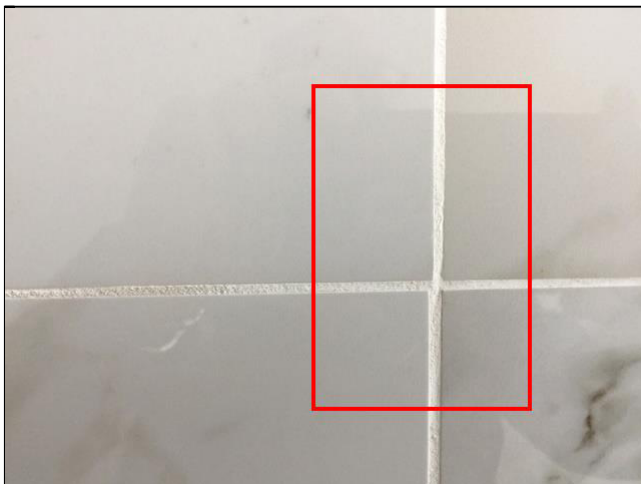
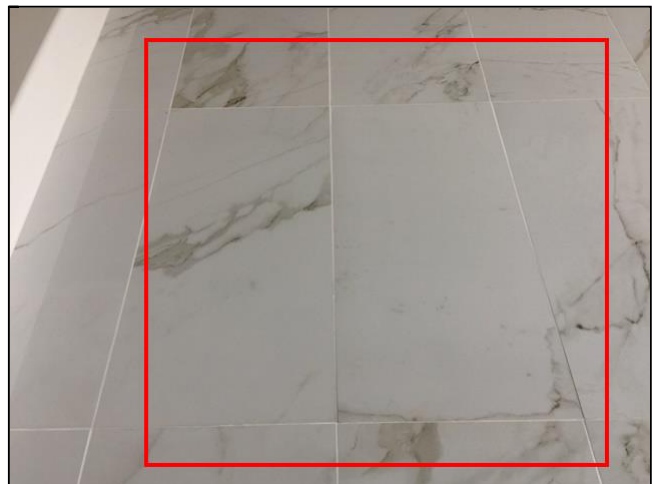
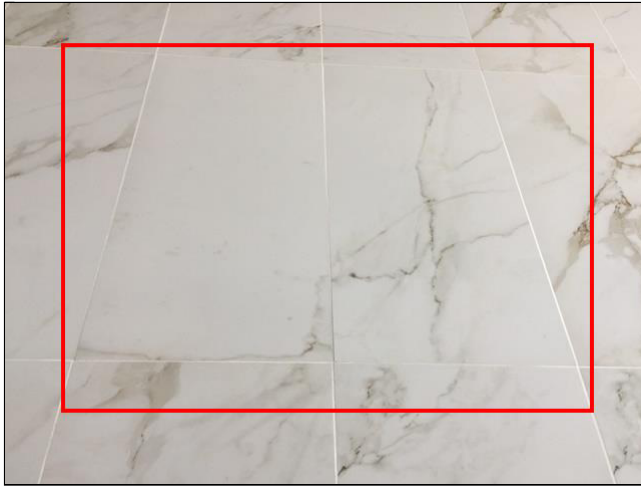
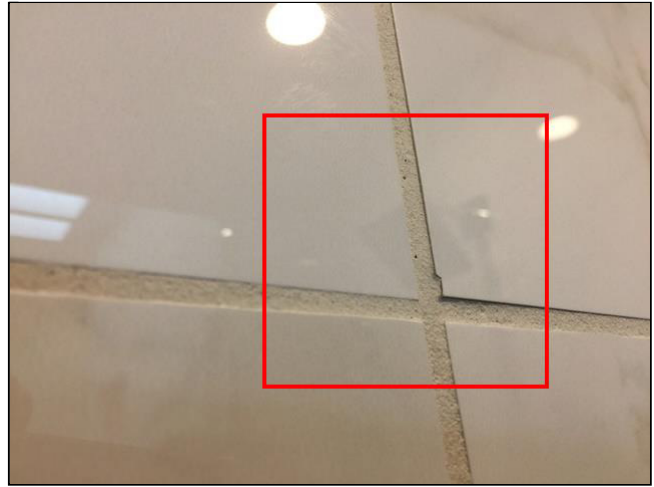
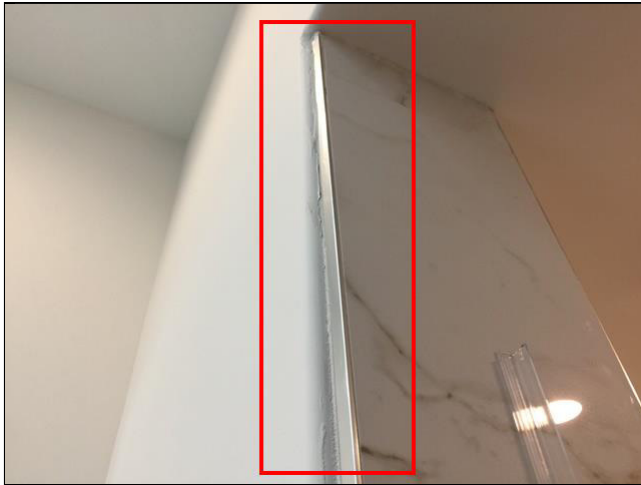
(5) Tile amiss. This condition was observed in several locations. The photographs depicted are only representative photographs of this finding. Tile chipped, grout lines not straight, and corner finishes questionable. This finding does not conform to building standards and practices in effect at the time of construction or installation. It is recommended that this Finding and all associated components be reviewed and corrected by the Prime Contractor.

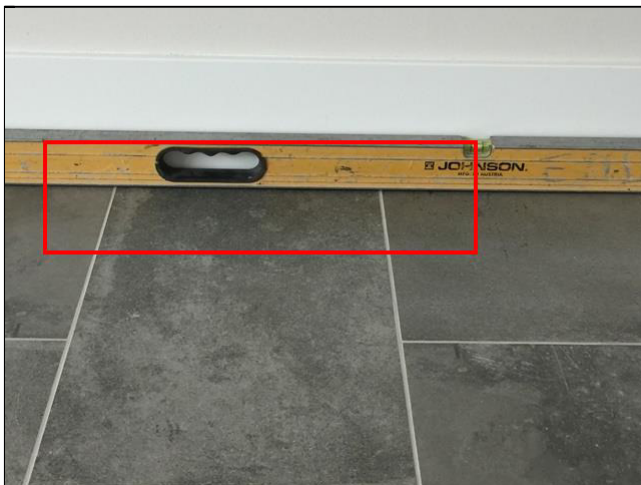
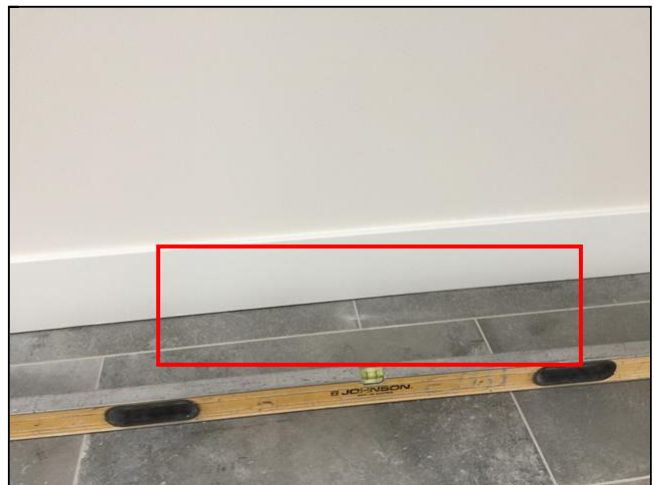
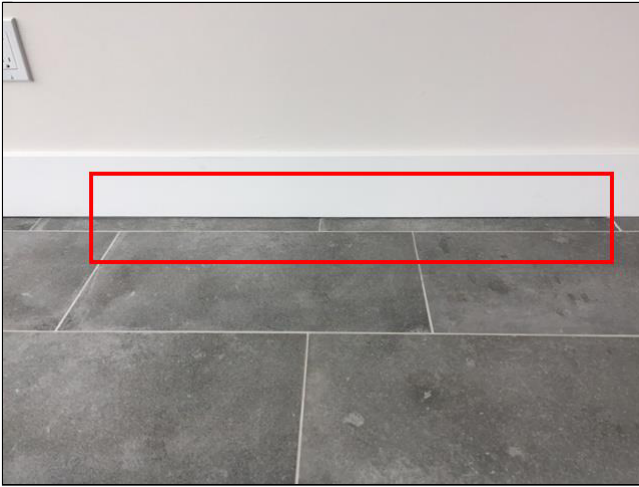
Tile uneven. This condition was observed in several locations in the home. The photographs depicted are only representative photographs of this finding. Tile should not exceed the manufacturer's recommendations or 1/16 inch lippage in absence of manufacturer's recommendations. This Finding does not conform the minimum required workmanship or craftsmanship performance standards as defined by the SNHBA and affirmed by the Nevada State Contractors Board. It is recommended the Prime Contractor review this finding and correct as needed to conform with applicable building standards and practices.

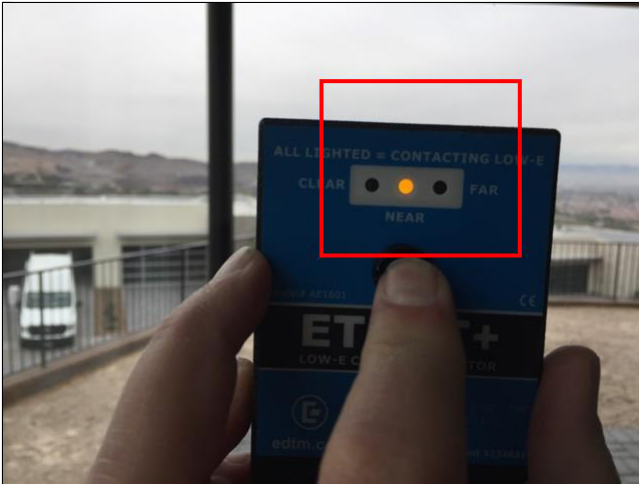
9.3 Item 1(Picture)

Low-E glazing anomaly noted. This condition was observed in the living room. The window has been installed backwards which will actually allow heat to pour into the home. Refer to the photograph for further clarification. It is recommended that this Finding and all associated components be reviewed and corrected by the Prime Contractor.

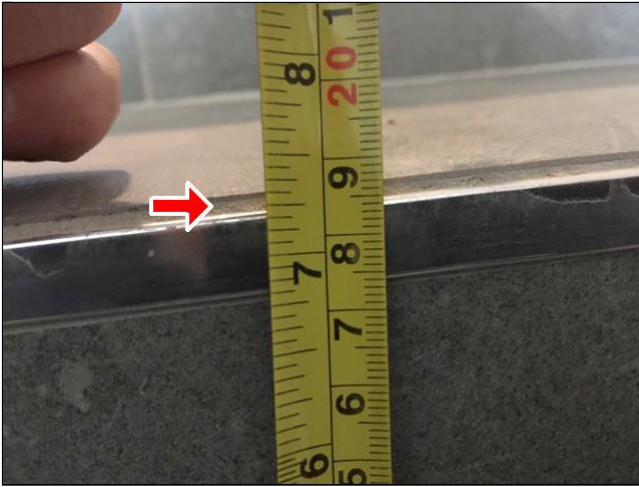
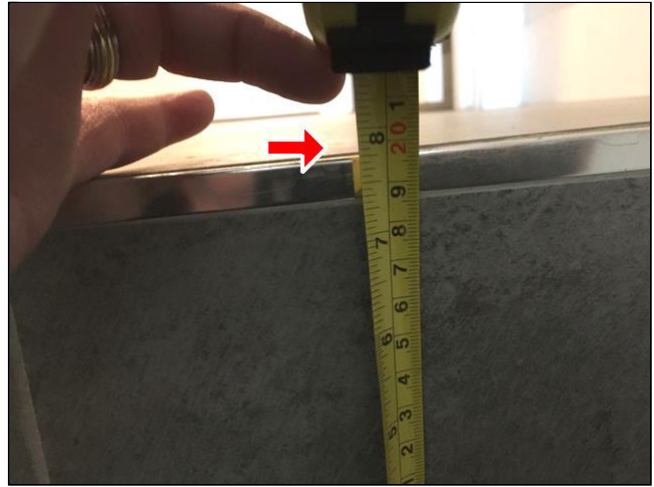
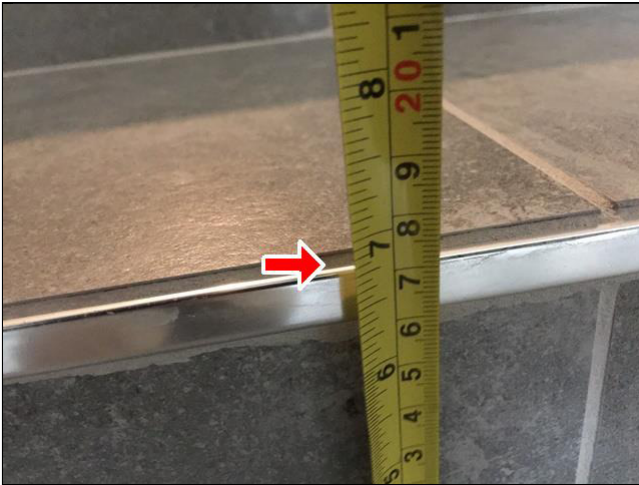
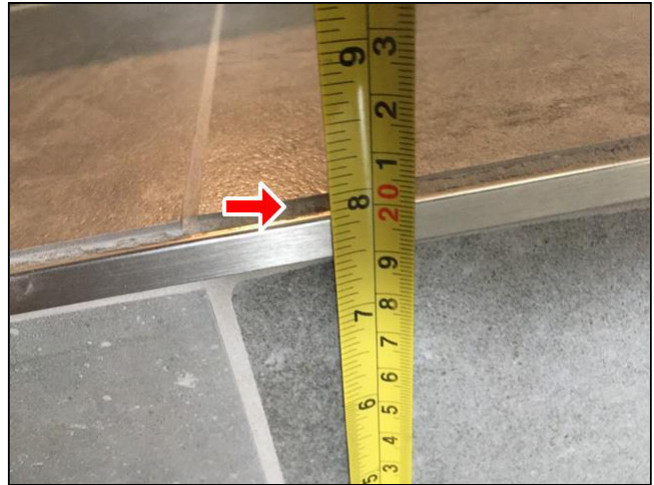
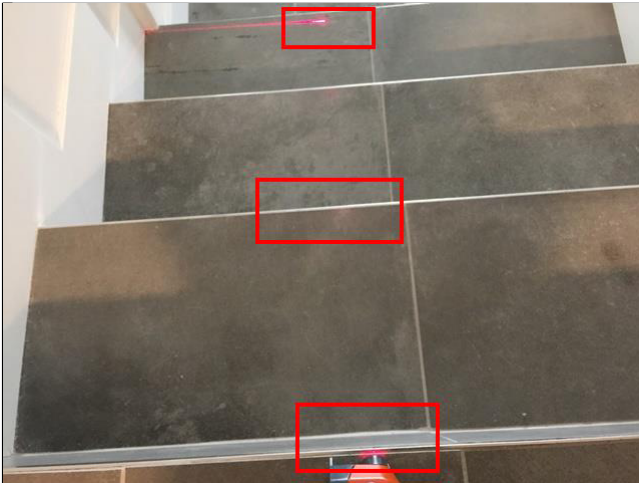
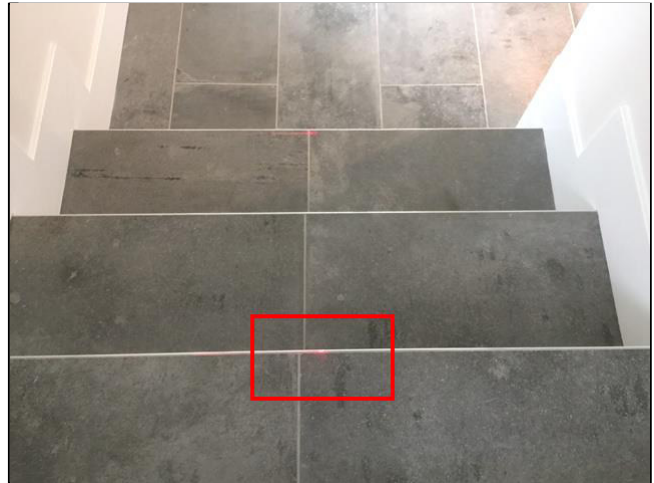
Stairs exceed maximum height / rise. This condition was observed on both sets of stairs. Refer to photographs for further clarification. The maximum height for a rise is 73/4 inches and the maximum difference between the highest and shortest rise is 3/8 inch according to the International Residential Code. It is recommended that this Finding and all associated components be reviewed and corrected by the Prime Contractor.

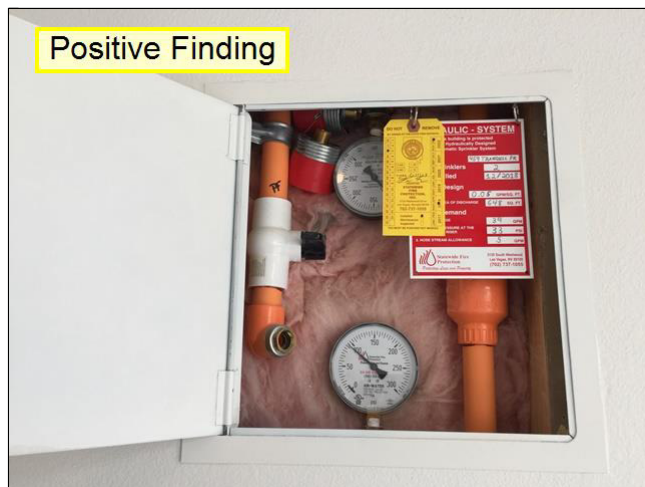
9.6 Item 1(Picture)

The client is advised that this home has a fire sprinkler system installed. Be sure to notify your insurance provider. Many insurance companies provide a discount when this system is installed.

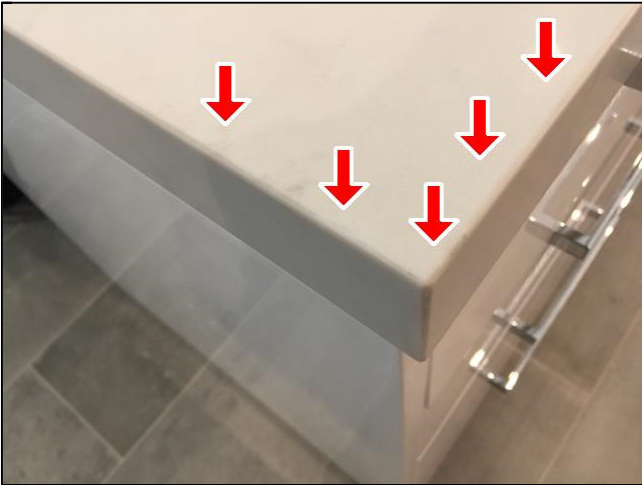
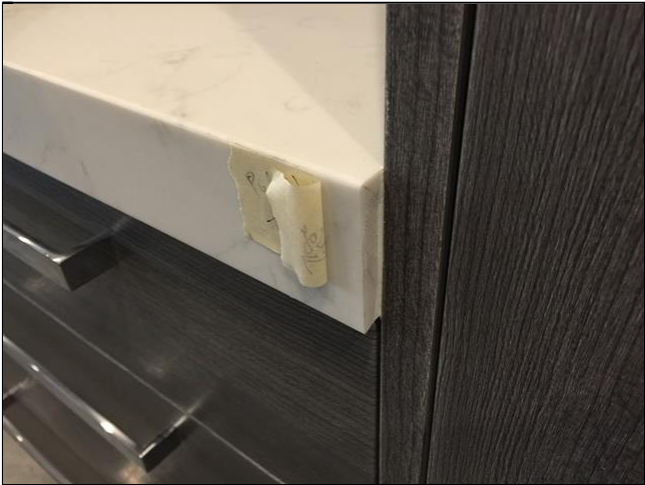
Counter top amiss. This condition was observed in the kitchen.. The photograph depicted is only a representative photograph of this finding. This finding does not conform to building standards and practices in effect at the time of construction or installation. It is recommended the Prime Contractor review this finding and correct as needed to conform with applicable building standards and practices.

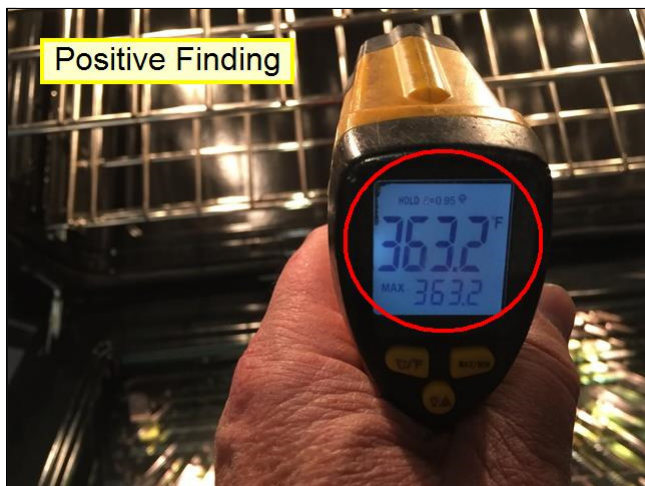
10.1 Item 2(Picture)

(2) Oven temperature verified. The oven, when tested at 350 degrees Fahrenheit, heated to 363 degrees Fahrenheit. Allowable tolerance is 350 +/- 25. The oven is well within allowable tolerance. This is a positive photo.

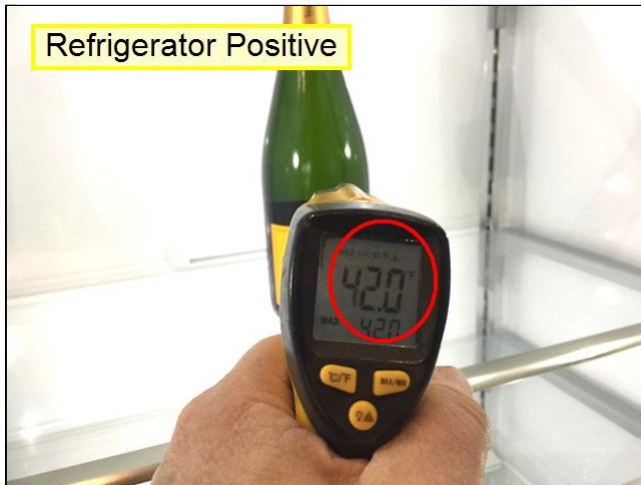
10.2 Item 1(Picture)

Refrigerator / freezer temperatures verified. The refrigerator and freezer temperatures were measured and appear to be within the acceptable ranges. The wine cooler, bar refrigerator and bar ice maker were all within industry standards. These are positive photographs.

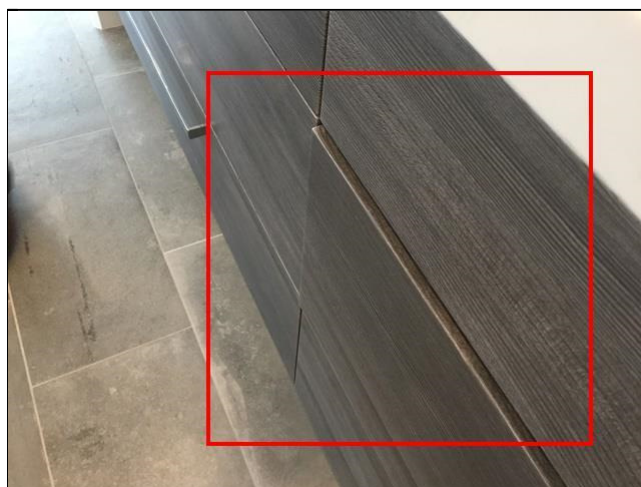
10.10 Item 2(Picture)

Cabinetry drawer issue. This condition was observed in several locations in the home. The photographs depicted are only representative photographs of this finding. This Finding does not conform the minimum required workmanship or craftsmanship performance standards as defined by the SNHBA and affirmed by the Nevada State Contractors Board. It is recommended the Prime Contractor review this finding and correct as needed to conform with applicable building standards and practices..

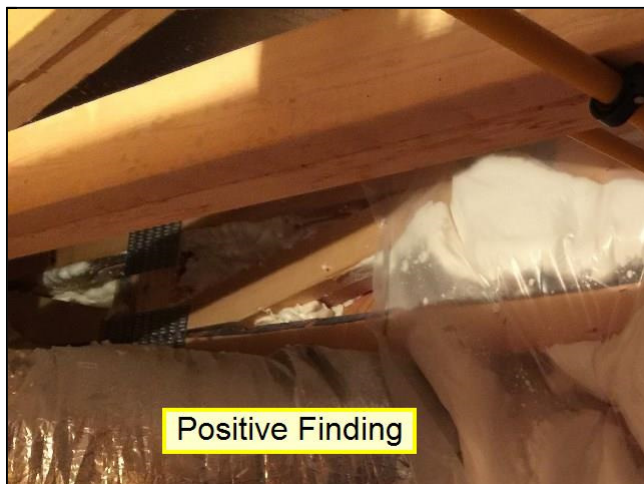
12.1 Item 1(Picture)

Roof trusses reviewed This condition was observed in the attic. The photograph depicted is only a representative photograph of this finding. The accessible roof trusses and other accessible framing components were reviewed with no adverse findings observed. This is a positive finding.

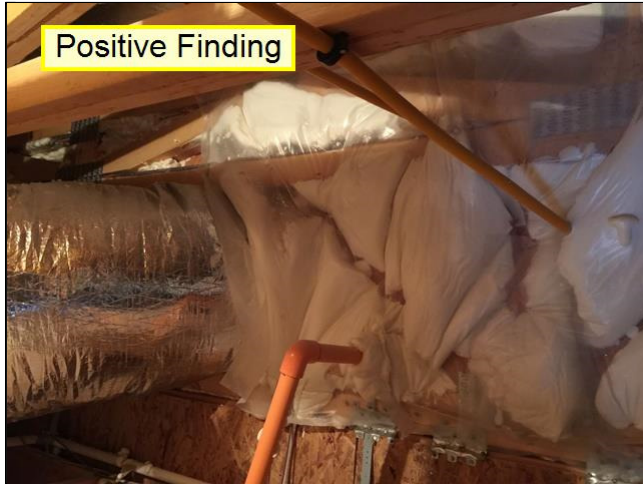
12.5 Item 1(Picture)

Attic fire /smoke separation walls observed. This condition was observed in the attic. The walls between the units in the attic are required to be fire rated and sealed. Refer to photographs for further clarification. This is deemed to be a positive finding.

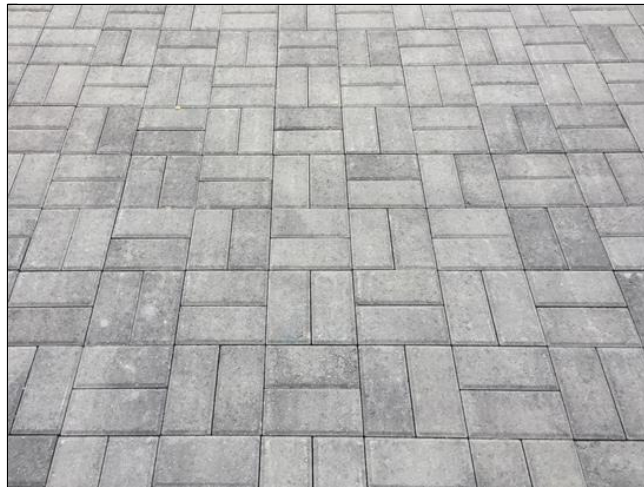
1.1 Item 2(Picture)

(1) Sand missing at paver blocks. This condition was observed at several locations around the structure. The photographs depicted are only representative photographs of this finding. Acceptable building standards state "Prior to final compaction of the surface, all joints should be filled with kiln dried fine jointing sand. All joints should remain full of jointing sand at all times, with periodic checking and re-sanding carried out where necessary." It is recommended that this Finding and all associated components be reviewed and corrected by the Prime Contractor.

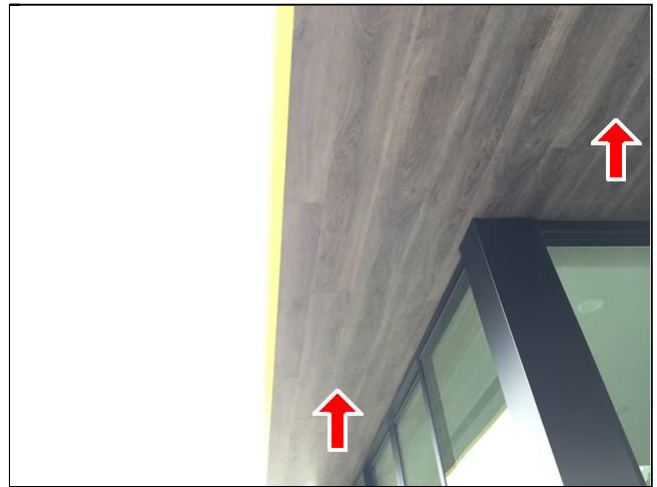
2.1 Item 2(Picture)

Vinyl laminate flooring use in soffit questionable. Refer to photographs for further clarification. Many manufactures take the stance that laminate flooring is not intended for outdoor use. There are some 'weather-resistant' laminates on the market, however most laminate floors are made strictly for indoor use. The flooring would warp and rapidly get damaged under changing weather conditions and would not last very long. Vinyl floor can be used in an outdoor, temperature controlled environment. This means that you can install vinyl flooring in a sun room, enclosed porch, or any other "outdoor" space where you can control the heat and cold. The manufacture of the product should be consulted as to the use in this manner and the installation instructions should be reviewed as to installation.

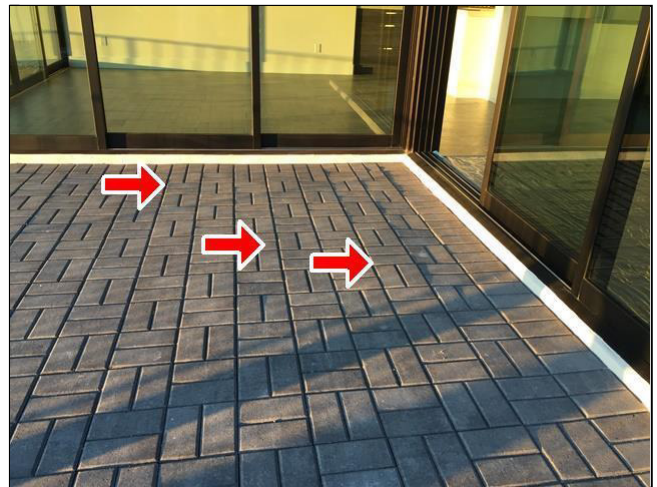
2.4 Item 2(Picture)

Improper drainage at rear patio. The pavers at the sliding glass doors are sloped into the building. The photographs depicted are only representative photographs of this finding. This Finding does not conform the minimum required workmanship or craftsmanship performance standards. It is recommended that this Finding and all associated components be reviewed and corrected by the Prime Contractor.

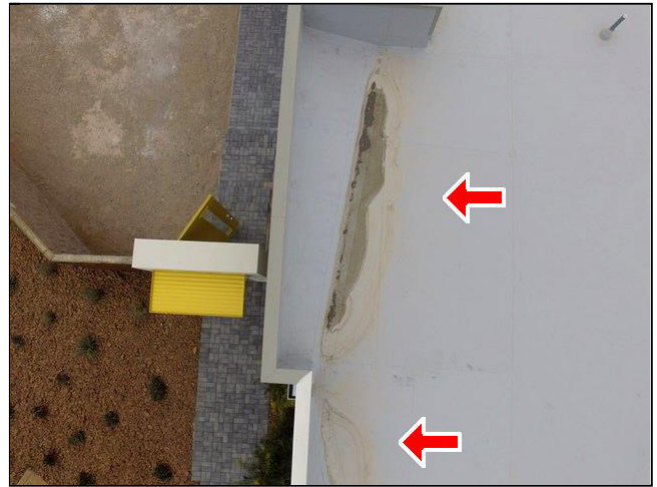
4.0 Item 2(Picture)

Pooling water appears to be observed on roof. Refer to photographs for further clarification. Nevada Contractors board states that " Roof sheathing should have a maximum deflection of 3/8 inch in 2 feet." This Finding does not conform the minimum required workmanship or craftsmanship performance standards as defined by the SNHBA and affirmed by the Nevada State Contractors Board. It is recommended the Prime Contractor review this finding and correct as needed to conform with applicable building standards and practices.

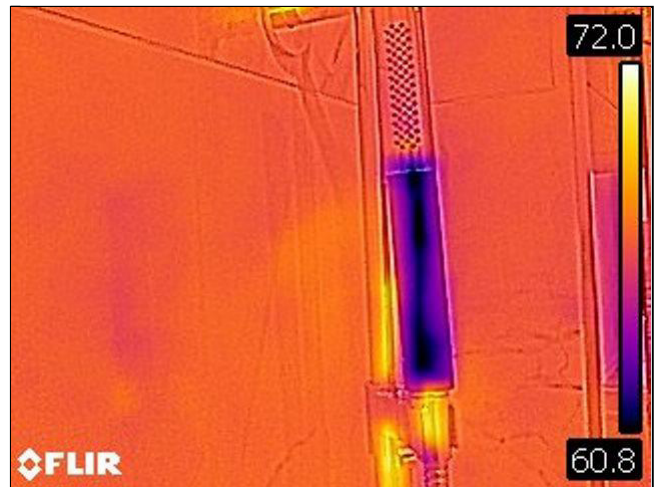
6.4 Item 2(Picture)

Water faucet leaking. This condition was observed at the hand wand in the master shower. Refer to the photographs for further clarification. Left uncorrected further accelerated deterioration will occur. This Finding does not conform the minimum required workmanship or craftsmanship performance standards as defined by the SNHBA and affirmed by the Nevada State Contractors Board. It is recommended the Prime Contractor review this finding and correct as needed to conform with applicable building standards and practices.

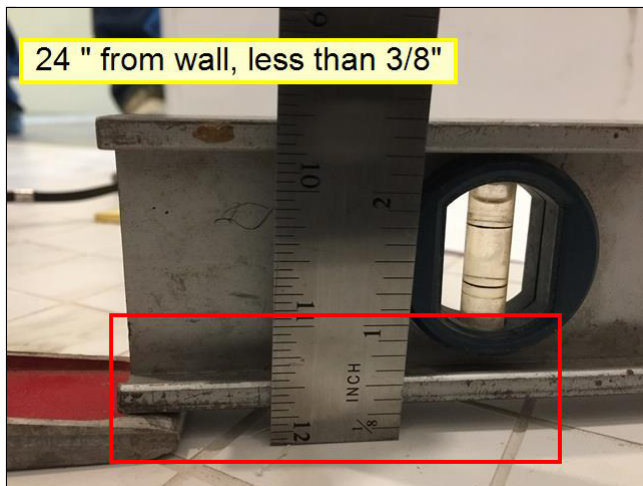
8.3 Item 1(Picture)

(1) Bathroom floor amiss. This condition was observed in the master bathroom shower. The photographs depicted are only representative photographs of this finding. The bathroom floor is improperly sloped. Standard building practices call for a minimum grade of 1/4 inch per lineal foot and a maximum grade of 1/2 inch per lineal foot. This Finding does not conform the minimum required workmanship or craftsmanship performance standards. It is recommended that this Finding and all associated components be reviewed and corrected by the Prime Contractor.

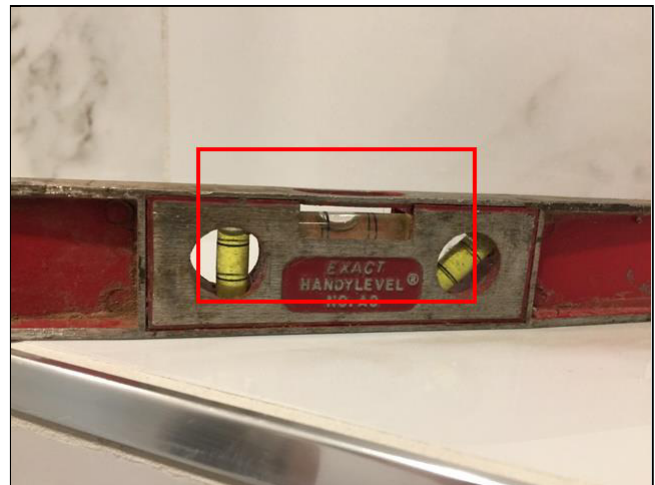
8.3 Item 7(Picture)

(2) Bathroom floor amiss. This condition was observed in the secondary bathroom shower. The photographs depicted are only representative photographs of this finding. The bathroom floor is improperly sloped. Standard building practices call for a minimum grade of 1/4 inch per lineal foot and a maximum grade of 1/2 inch per lineal foot. This Finding does not conform the minimum required workmanship or craftsmanship performance standards. It is recommended that this Finding and all associated components be reviewed and corrected by the Prime Contractor.

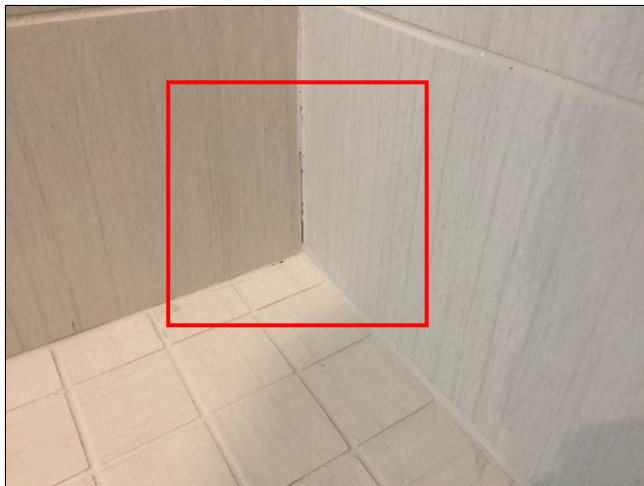
8.5 Item 1(Picture)

Grout amiss. This condition was observed in both bathrooms. The photographs depicted are only a representation of this finding. This Finding does not conform the minimum required workmanship or craftsmanship performance standards as defined by the SNHBA and affirmed by the Nevada State Contractors Board. It is recommended the Prime Contractor review this finding and correct as needed to conform with applicable building standards and practices.

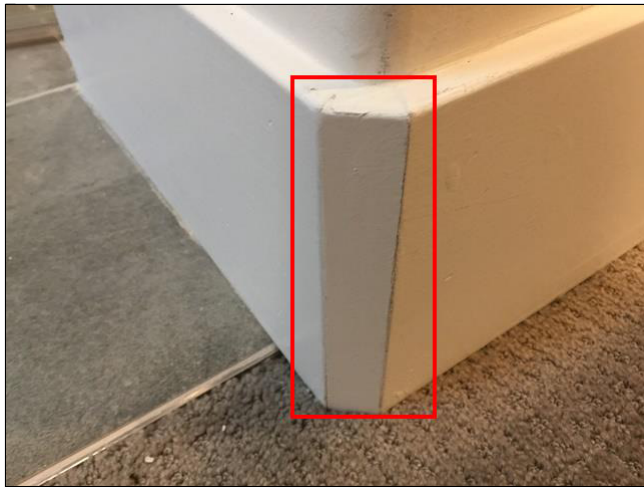
9.0 Item 1(Picture)

(1) Interior trim gaped This condition was observed in several locations in the home. The photographs depicted are only representative photographs of this finding. This Finding does not conform the minimum required workmanship or craftsmanship performance standards as defined by the SNHBA and affirmed by the Nevada State Contractors Board. It is recommended the Prime Contractor review this finding and correct as needed to conform with applicable building standards and practices.

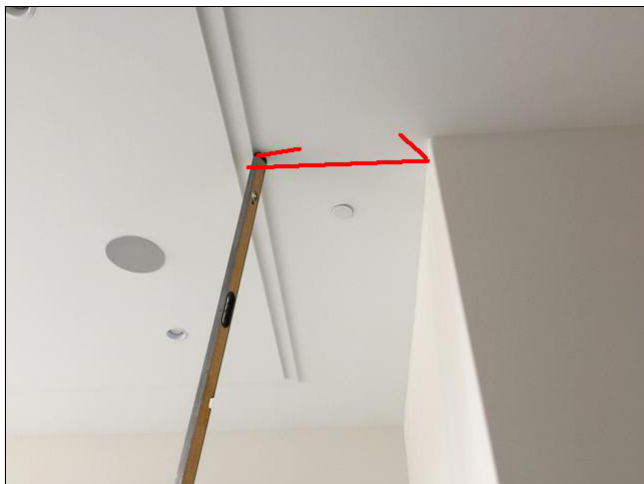
9.0 Item 4(Picture)

(2) CEILINGS THAT ARE OUT OF LEVEL OR SQUARE

Performance Guideline: Unevenness of floors or ceilings should not exceed 1/8 inch in 4 feet and should be level within 1/4 inch in 10 feet. This Finding does not conform the minimum required workmanship or craftsmanship performance standards as defined by the SNHBA and affirmed by the Nevada State Contractors Board. It is recommended the Prime Contractor review this finding and correct as needed to conform with applicable building standards and practices.

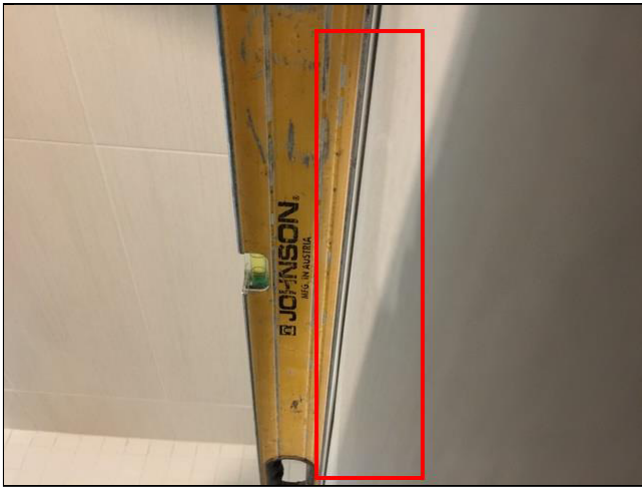
9.0 Item 6(Picture)

(3) Walls out of plumb. This condition was observed in several areas of the home. The photographs depicted are only a representation of this finding. United Facilities Guide Specification (UFGS) suggests a tolerance of 1/4" in 8' for plumbness of studs when finishes such as wallboard, plaster or ceramic tile set in a mortar bed are used. It is recommended that this Finding and all associated components be reviewed and corrected by the Prime Contractor.

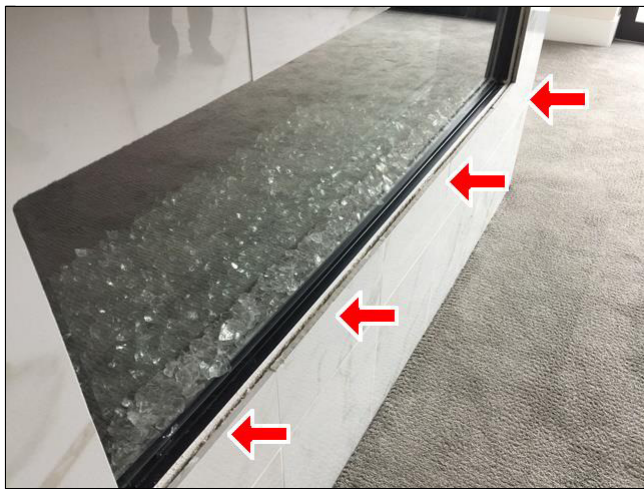
9.0 Item 13(Picture)

(4) Wall appears improperly finished. This condition was observed in the living room. Refer to the photograph for further clarification. In accordance with Nevada State Contractors Board Performance Guidelines texture should present a uniform appearance when viewed under natural lighting conditions at a distance of 5 feet. It is recommended that this Finding and all associated components be reviewed and corrected by the Prime Contractor.

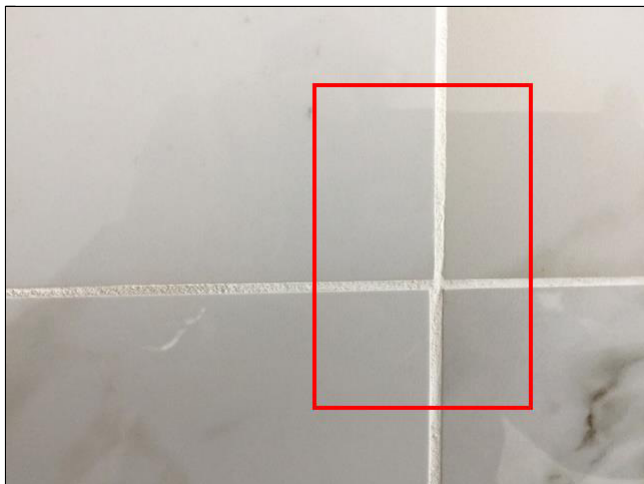
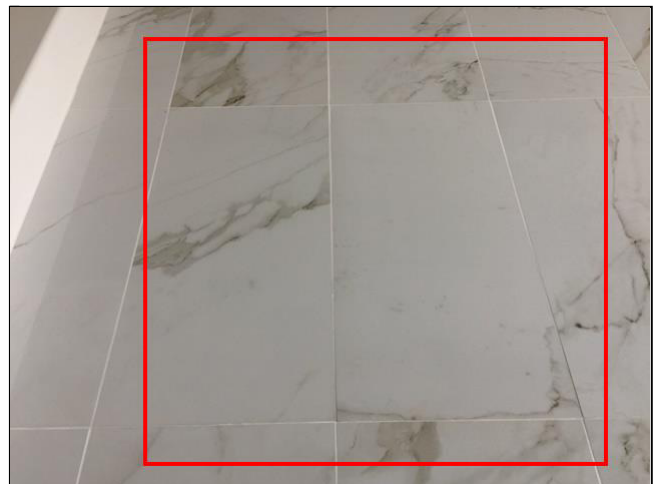
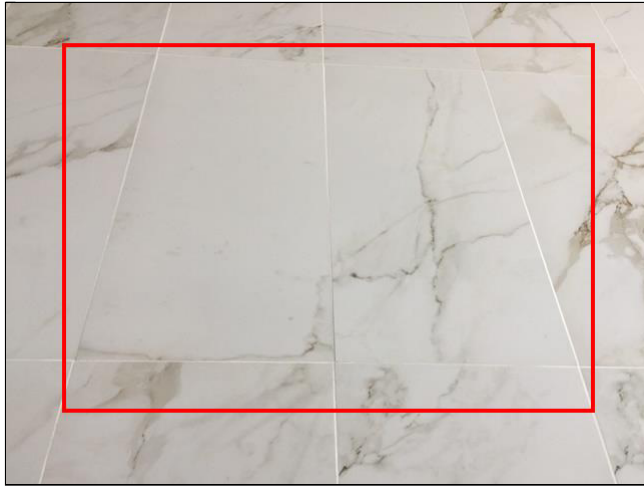
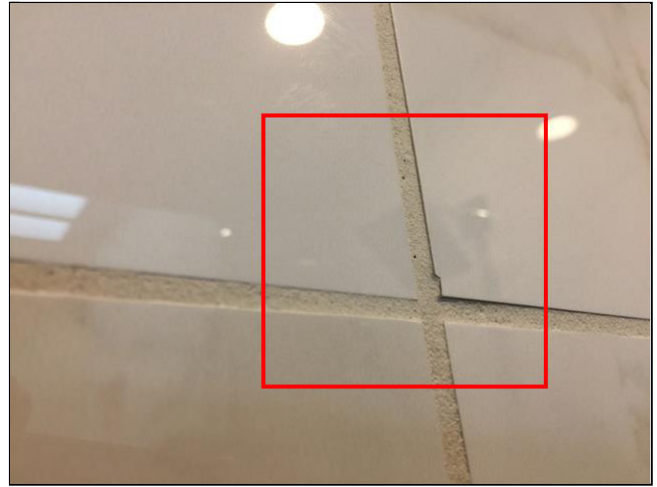
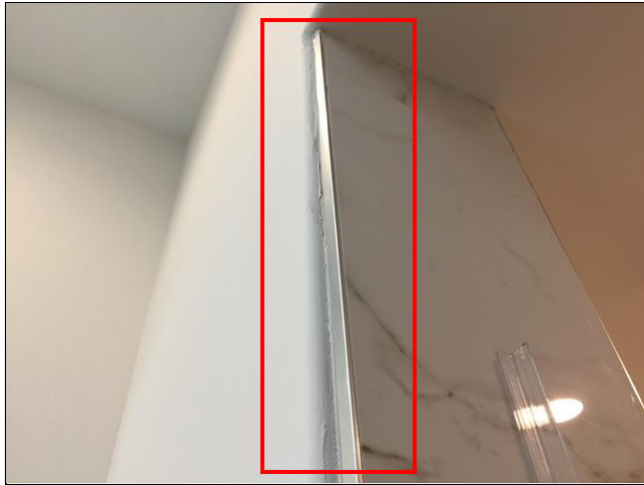
(5) Tile amiss. This condition was observed in several locations. The photographs depicted are only representative photographs of this finding. Tile chipped, grout lines not straight, and corner finishes questionable. This finding does not conform to building standards and practices in effect at the time of construction or installation. It is recommended that this Finding and all associated components be reviewed and corrected by the Prime Contractor.

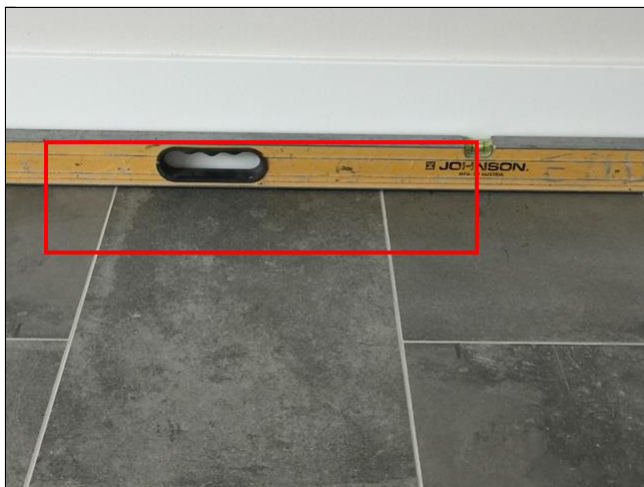
9.1 Item 1(Picture)

Tile uneven. This condition was observed in several locations in the home. The photographs depicted are only representative photographs of this finding. Tile should not exceed the manufacturer's recommendations or 1/16 inch lippage in absence of manufacturer's recommendations. This Finding does not conform the minimum required workmanship or craftsmanship performance standards as defined by the SNHBA and affirmed by the Nevada State Contractors Board. It is recommended the Prime Contractor review this finding and correct as needed to conform with applicable building standards and practices.

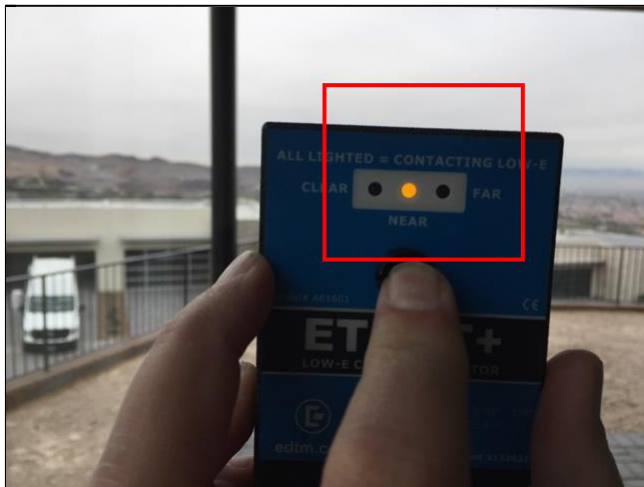
9.3 Item 1(Picture)

Low-E glazing anomaly noted. This condition was observed in the living room. The window has been installed backwards which will actually allow heat to pour into the home. Refer to the photograph for further clarification. It is recommended that this Finding and all associated components be reviewed and corrected by the Prime Contractor.

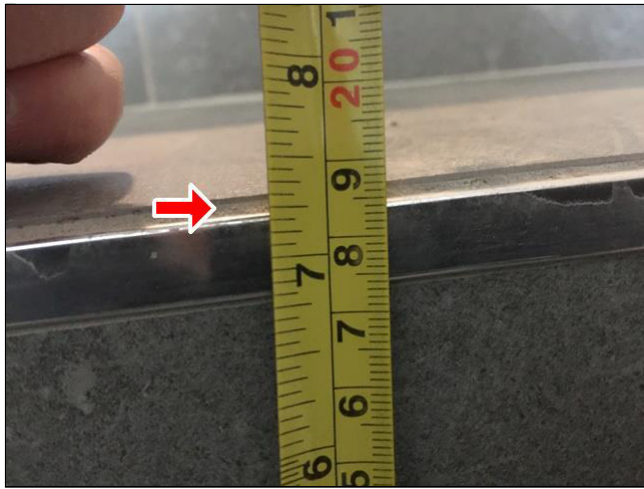
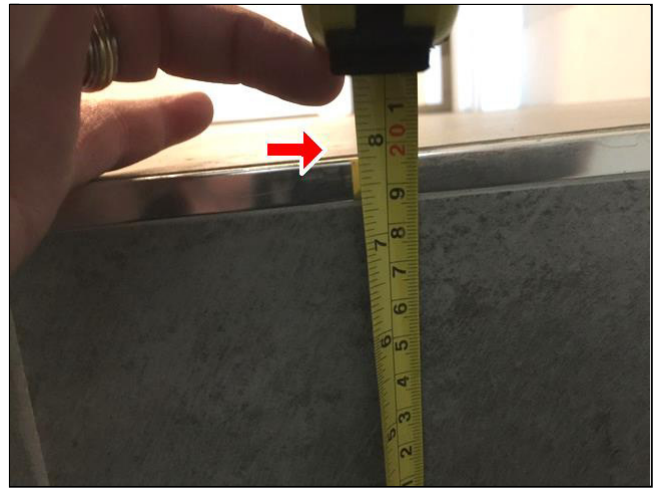
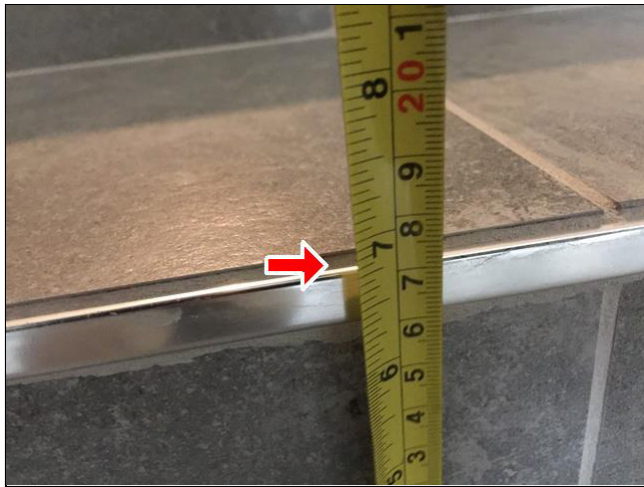
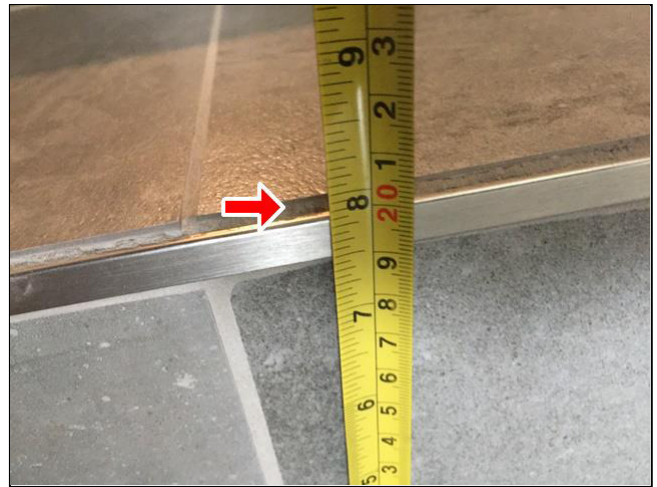
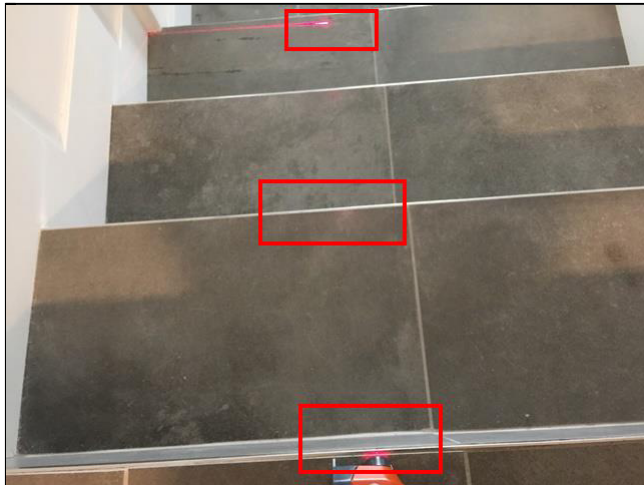
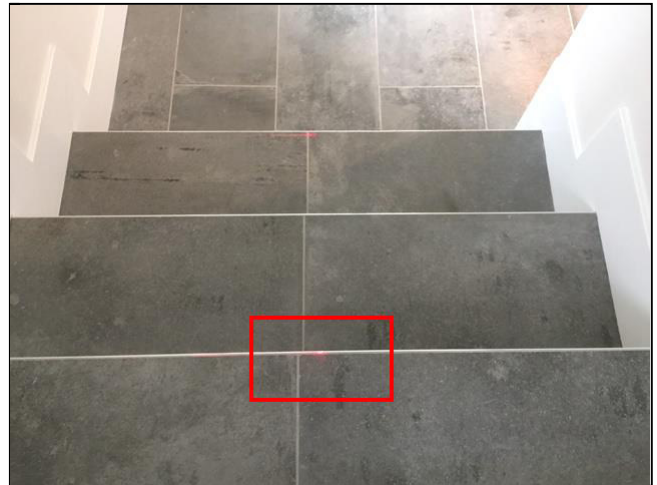
Stairs exceed maximum height / rise. This condition was observed on both sets of stairs. Refer to photographs for further clarification. The maximum height for a rise is 7 3/4 inches and the maximum difference between the highest and shortest rise is 3/8 inch according to the International Residential Code. It is recommended that this Finding and all associated components be reviewed and corrected by the Prime Contractor.

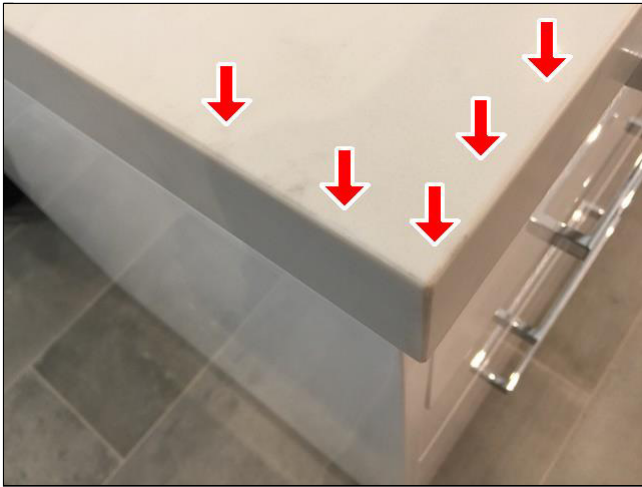
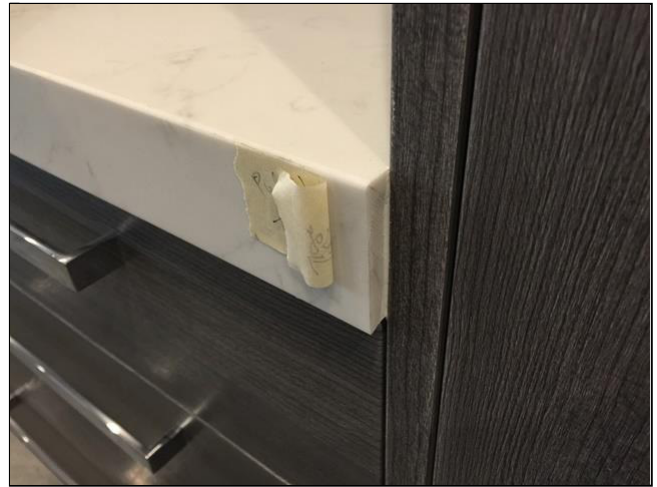
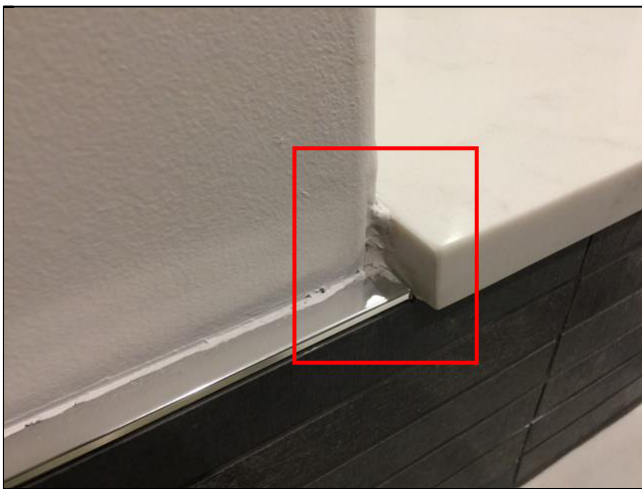
Counter top amiss. This condition was observed in the kitchen.. The photograph depicted is only a representative photograph of this finding. This finding does not conform to building standards and practices in effect at the time of

construction or installation. It is recommended the Prime Contractor review this finding and correct as needed to conform with applicable building standards and practices.

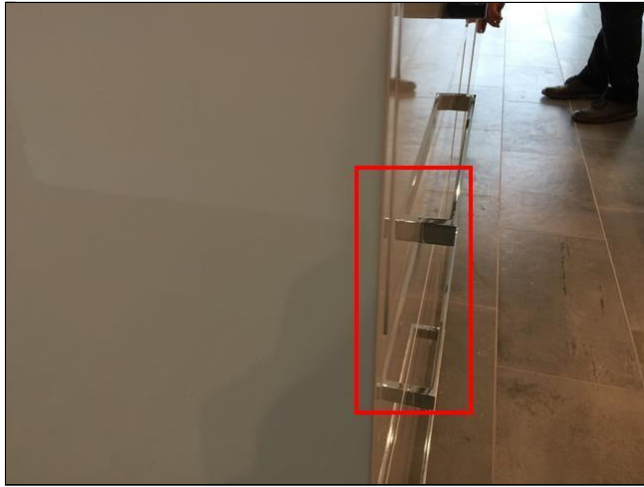
10.10 Item 1(Picture)

Cabinetry drawer issue. This condition was observed in several locations in the home. The photographs depicted are only representative photographs of this finding. This Finding does not conform the minimum required workmanship or craftsmanship performance standards as defined by the SNHBA and affirmed by the Nevada State Contractors Board. It is recommended the Prime Contractor review this finding and correct as needed to conform with applicable building standards and practices..

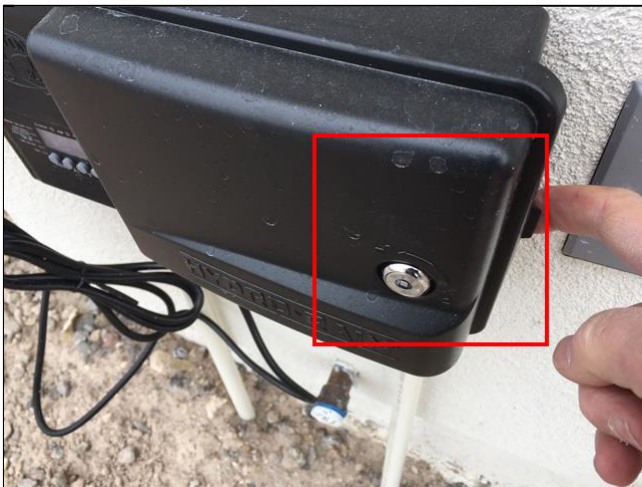
1.4 Item 1(Picture)

Access impaired. This condition was observed on the South side of the property. Refer to the photograph for further clarification. The controller was locked and the proper operation of the controller could not be observed. Further investigation is advised.
